Application of Optical Fiber Sensors for Crack Monitoring in a Masonry Structure during Geotechnical Foundation Remediation

This paper aims to propose a monitoring strategy for the assessment of the efficiency of polyurethane resin injection as a treatment technique in damaged masonry structures. The polyurethane resin injection technique is mainly adapted in repairing shallow foundations by densifying the soil and increasing its bearing capacity. Since the distribution path of this expansive resin into the soil is not well known, it makes it difficult to avoid further structural damage to the buildings. In order to avoid these kinds of additional damages on a cracked masonry structure, a field measurement technique was adapted during geotechnical remediation operations. Fiber Optic Sensors (FOS) were installed on four angles of the building in order to measure the local micro strains of the walls as well as the existing cracks dynamics (openings/closings). A geotechnical investigation survey was also carried out both at laboratory and field scale before and after the treatment process. The mechanical properties of the soil were investigated before and after the remediation proces

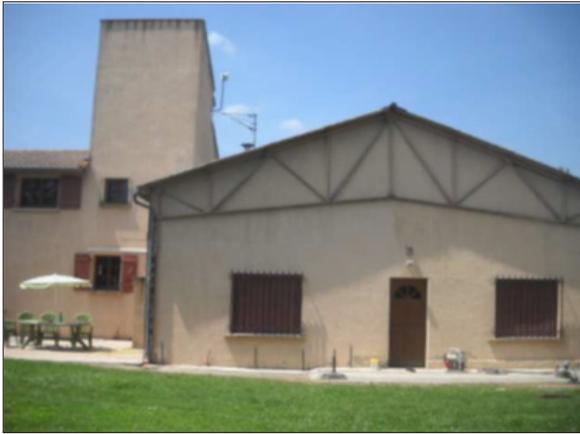
Figure 4: General view of the studied site.

The studied masonry structure is a one floor residential structure constructed with strip footing and is affected by shrinkage

and swelling of clayey soils. The cracks on walls are mostly 45° and vertical. The site is located in the Castelnau d'Estretfond region in France (Figure 4).

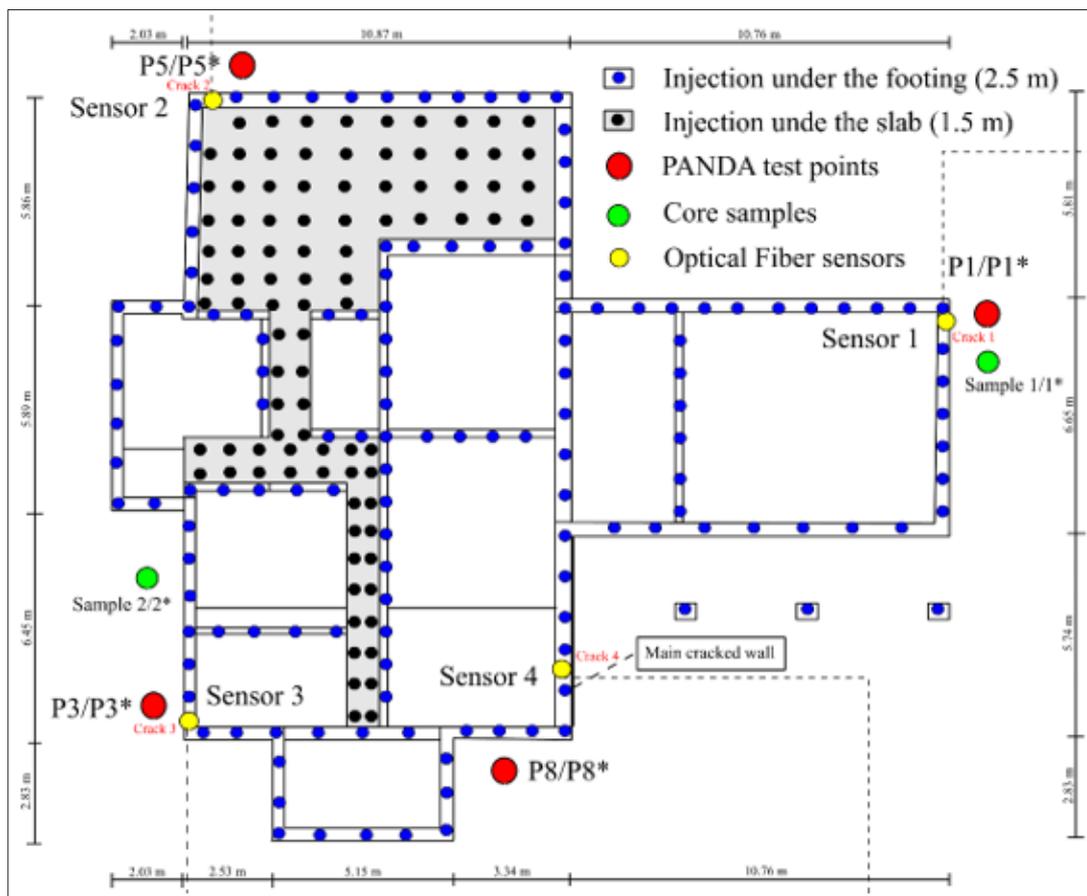
Figure 5: The general map of the studied building and the position of geotechnical test points with the location of the optical fiber sensors.

Four optical fiber sensors were installed on four different angles of the building (Figure 5) which were used in dynamic acquisition mode with a sampling rate of 20 milliseconds and a resolution of $20\mu m$. Each strain measurement was made when the injection was taking place at that specific point. Three sensors were installed on the walls on micro cracks. However, one of the sensors (sensor 4) was installed on the largest crack of the building (0.8-1mm).

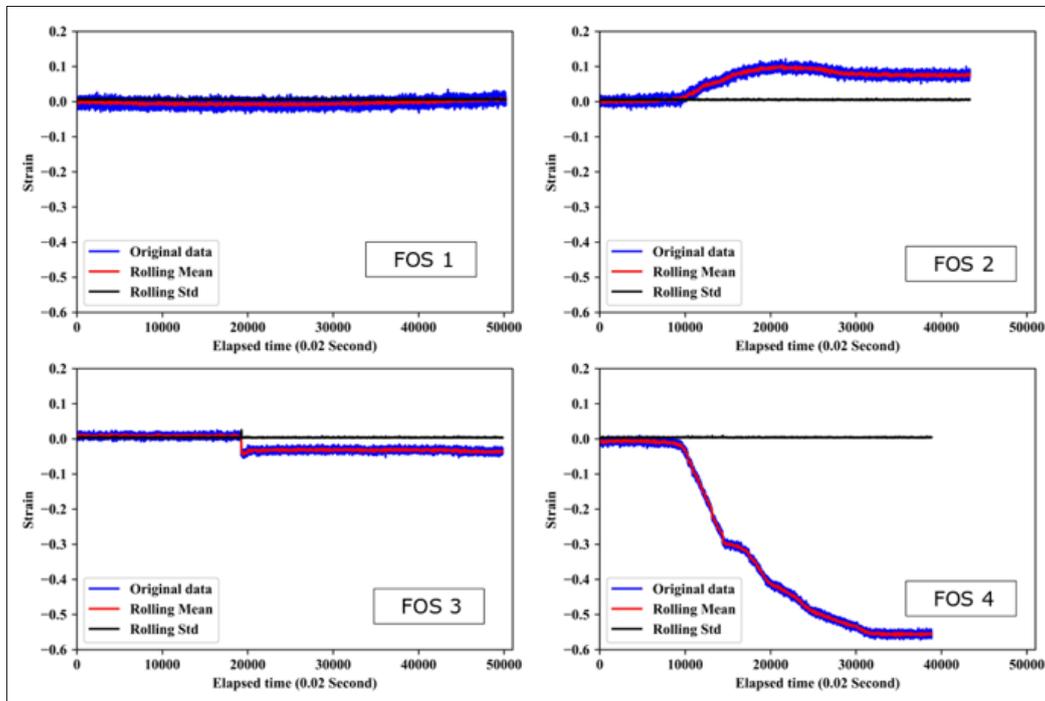
Figure 6: Results obtained from the optical fiber sensors at 4 different position of the building (μm).

(moving average) and standard deviations. The four FOS show all a general negative trend which is characterized by a compression in the monitored elements. This means that the cracks, especially the largest crack (FOS 4) are being closed during the injection operations expect the FOS 2 which shows a positive trend i.e. a traction in the monitored element.

A. FOS 1: the injection under the monitored wall with sensor 1, showed a stable behavior of the structure during the injection. The wall was slightly compressed (0.02mm) during the injection and when the injection was completed, it went back to its initial state. The results of the PANDA test at this point (P1/P1*) showed a significant improvement of the dynamic resistance in the first 60cm of the soil profile but a decrease from 60cm to 2m depth. It is generally concluded that the wall at this point was stable and the soil has been improved in the first meter.

B. FOS 2: shows mainly a tension of the optical fiber from the beginning of the injection. 35kg of resin was injected at this point, but the results of the optical fiber measurements did not show any compression at the beginning meaning that the resin was not being distributed at the considered spot under the footings. It was then observed that the resin was diffused under the slab instead. However, a compression phase and a rising up of the wall is captured by the sensor 2 at the end of the monitoring period. The injection was stopped right after the compression phase was observed. The results of the PANDA test at this point (P5/P5*) did not show any changes in the soil profile as expected because the resin was not distributed in the considered spot.

C. FOS 3: shows that the injection under the footing at this point has led to an overall rise in the structure resulting in a stable response of the optical fiber sensor. 25 Kg of resin were injected under this wall without causing any damage. Results of the PANDA test in the vicinity of this point (P3/P3*) show a slight improvement in the top layer of the profile and almost no change in the dynamic resistance after the injection phase. It can be derived that the complementary PANDA test after the injection (P3*) was not able to capture the effects of the injection but the stability of the structure was confirmed with the optical fiber sensor. Complementary in-situ tests can confirm the improvements of the soil mechanical properties at this point.

D. FOS 4: shows the results of the crack openings installed on the largest external crack and potentially the most damaged part of the building. This unique curve shows that the resin injection under the foundation soil resulted in a closure of

the crack in a range of 0.5 mm. 27 kg of resin were injected at this point and the results from the PANDA test carried out before and after the injection phase (P8/P8*) show significant improvements in the soil profile.

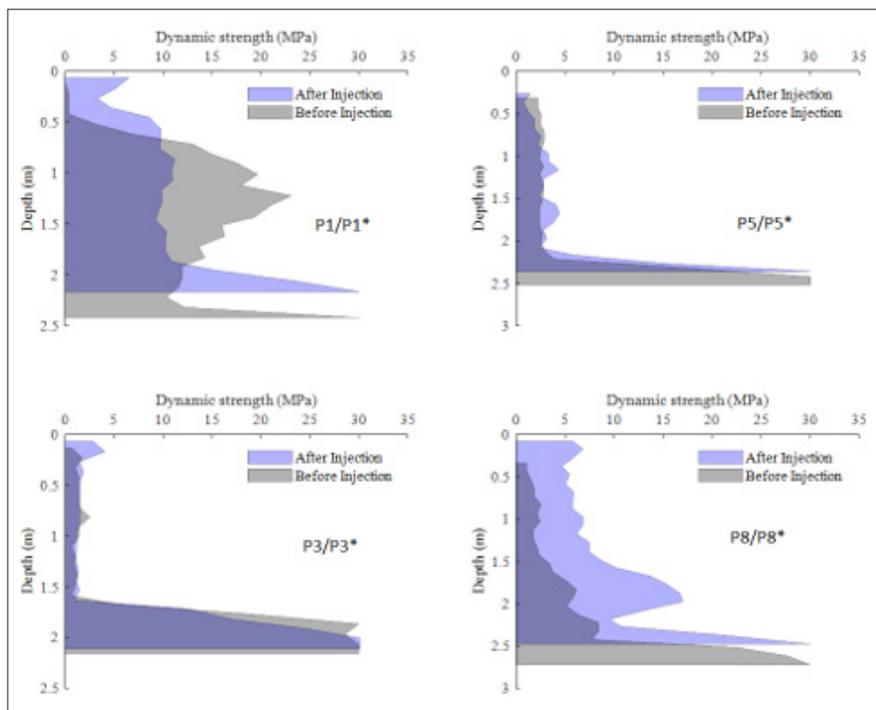
Figure 7: Results of in-situ PANDA tests before and after the injection process.

Results of the laboratory experiments on the samples before and after the injection showed that the material is not always homogenous, and samples may not be affected by the injection during the remediation process. Furthermore, results of the in-situ dynamic resistance of the soil are presented in Figure 7. It can be generally observed that there is an improvement of the tip resistance in the soil close to the FOS 1 and FOS 4 sensors (P1 and P8). These sensors also showed a negative trend (closing of the cracks). It should be mentioned that in other test points (P3 and P8), the tip resistance has not changed or just slightly improved after remediation.
