Frost Action Damages Effect in Correlation with IRI Data: A Study on Sections of Road BD97 and BD841

Ludvig Danfors¹, Niklas Mannelqvist¹, Tarun Bansal^{1*} and Virgilio Pérez²

¹Luleå University of Technology, Sweden

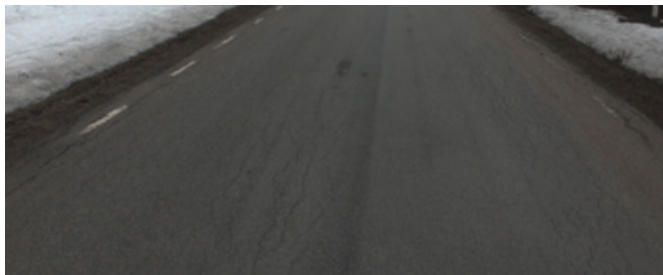
The road damages caused by bearing capacity are only identified to separate them from frost action damages, i.e., these damages are not documented and taken into consideration in the result. There are two important characteristics of bearing capacity damages that have been decisive when looking through the pictures. The first characteristic is micro-cracks in the road surface as shown in Figure 2 which are mainly caused by aged asphalt.

Figure 2: Micro-cracks in the pavement caused the bearing capacity failure. The picture is taken at section 46082 on road BD841 with an IRI measuring vehicle and is provided by Ramboll.

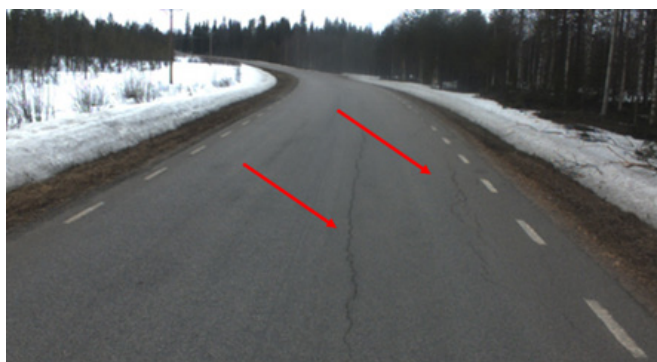
The other characteristic is failures in the wheel tracks as shown in Figure 3 below. These cracks are developed when the bearing capacity is exceeded. The difference in bearing capacity cracks compared to frost cracks, which are quite similar in appearance, is the smaller width, location in wheel tracks and straightness. Figure 3, Cracks in wheel tracks caused by bearing capacity failure. A picture is taken on section 46607 on road BD841 with an IRI measuring vehicle and is provided by Ramboll.

Figure 3: Cracks in wheel tracks caused by bearing capacity failure. A picture is taken on section 46607 on road BD841 with an IRI measuring vehicle and is provided by Ramboll.

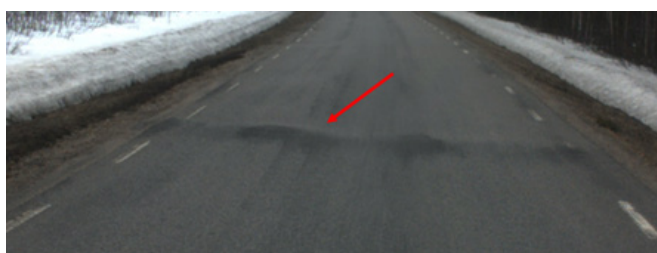
Figure 4: Positive culvert movement from road BD841. The picture is taken on road BD841 at section 46797 with an IRI measuring vehicle and is provided by Ramboll.

Culvert movement: A culvert movement can be both positive and negative. It is defined as positive, see Figure 4, when there is an upward buckling and negative, see Figure 5, when there is a dip in the road. A culvert makes it easy for cold air to travel inside and thereby cause frost action heave on surrounding frost susceptible

soil. The positive culvert movement is created when the soil is heaving due to the frost action. If the frost action heave on the soil around the culvert rises higher, this may be experienced as a dip in the road and classified as a negative culvert movement [6]. Figure 4, Positive culvert movement from road BD841. The picture is taken on road BD841 at section 46797 with an IRI measuring vehicle and is provided by Ramboll. Figure 5, Negative culvert movement. The picture is taken on road BD841 at section 50499 with an IRI measuring vehicle and is provided by Ramboll.

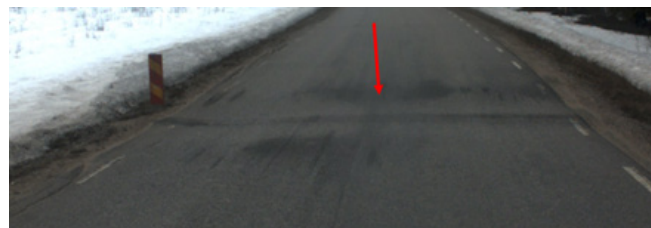
Figure 5: Negative culvert movement. The picture is taken on road BD841 at section 50499 with an IRI measuring vehicle and is provided by Ramboll.

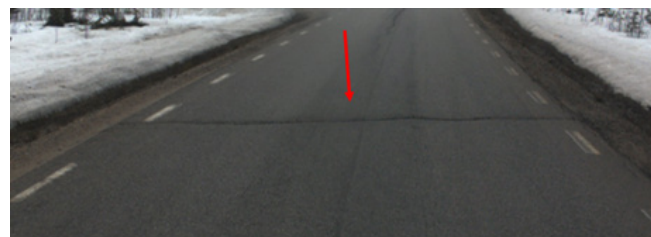
Figure 6: Temperature crack. The picture is taken on road BD841 at section 51409 with an IRI measuring vehicle and is provided by Ramboll.

Temperature cracks: Since asphalt, like many other materials, can shrink during a period of low temperatures, it results in so-called

temperature cracks. As seen in Figure 6, they appear as transversal cracks in the pavement with regular distance in-between [3]. Figure 6, Temperature crack. The picture is taken on road BD841 at section 51409 with an IRI measuring vehicle and is provided by Ramboll.

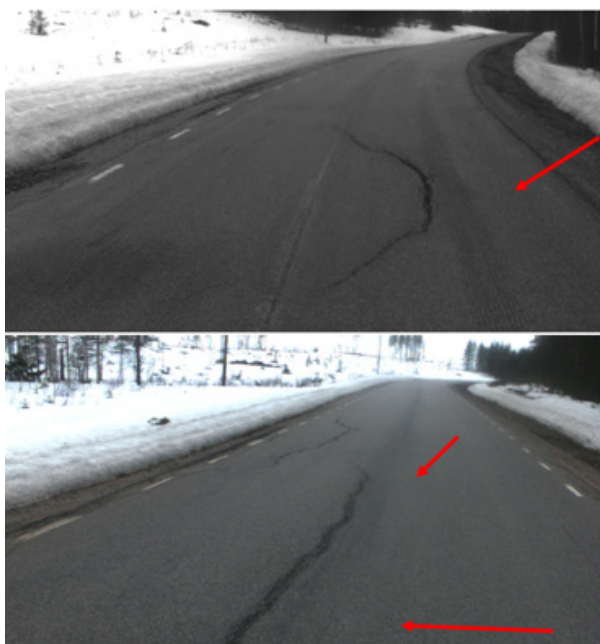
Frost cracks: Frost cracks are caused by uneven frost heaving and appear as longitudinal and widened cracks. The uneven frost heaving can be caused by an isolating snow layer surrounding the road. The occurrence is dependent on many factors like chosen construction material and temperature. The location is varying depending on the width of the road. Roads with a width of 5-6 or 12-13 meters tend to develop frost cracks on each side. Roads with a width of 7-9 meters tend to develop frost cracks in the middle of the road [9]. Figure 7, Frost cracks. The picture is taken on road BD841 at section 49874 and 49709 with an IRI measuring vehicle and is provided by Ramboll.

Figure 7: Frost cracks. The picture is taken on road BD841 at section 49874 and 49709 with an IRI measuring vehicle and is provided by Ramboll.
