# Assessment of the Various Slope Stabilization Initiatives Undertaken along the Pathways of Shri Mata Vaishno Deviji Shrine, Jammu and Kashmir Himalaya, India

Naithani AK<sup>1\*</sup> and Nawani PC<sup>2</sup>

<sup>1</sup>National Institute of Rock Mechanics, India

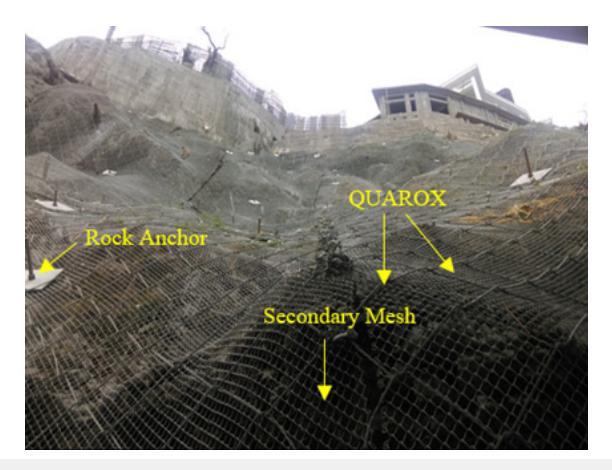
**Figure 1:** Treatment of location-3 slope by applying QUAROX with secondary mesh and rock anchors.

Scaling of surface i.e., removal of loose materials and small rock chunks was done before applying protection measures. Total 106m<sup>3</sup> material was excavated by mechanical means i.e., hydraulic excavator and manual means. Slope was treated with QUAROX to hold the fractured rock mass on the cliff of rock and TECCO for treatment of slopes where small rock fragments/debris were present. Below QUAROX, secondary mesh, made of G.I. wire of dia. 2.4 mm was placed. Erosion control mat (TECMAT) below TECCO in debris covered areas was applied to support vegetation. TECMAT is made up of Polypropylene (PP) monofilaments and is typically used in combination with a TECCO mesh cover and an appropriate nailing. TECMAT was applied as a bioengineering measure in a 1360m<sup>2</sup> area. Where QUAROX was applied, full column grouted (1:1 sand & cement), 8.0m length and 28mm dia. anchor bolts at a spacing of 2.0m c/c in staggered fashion were installed. Where TECCO was applied, full column grouted (1:1 sand & cement), 6.0m length and 25mm dia. anchor bolts at a spacing of 2.0m c/c in staggered fashion were installed. For grouted rock anchors, dia. of hole was 90mm and 70mm dia. for 28mm and 25mm anchor bolts respectively. In other areas also wherever required, 25mm dia., 6.0 - 8.0m length grouted rock anchor bolts were installed. 100mm thick shotcrete in 2 layers with chain link mesh was applied on the rock surface after cleaning of slope. The chain link fabric was made up of G.I. wire of dia. 2.8mm and it was anchored with a 1.0m length dowel. Concrete cladding wall of M-25 grade is constructed just below the temple. Consolidation grouting (1:2 & 1:3 water & cement) through 38mm dia. holes up to 10m depth were done in the cladding wall at 2.0m interval from the bottom. Consolidation grouting was also done throughout the area with the same specification with 2 to 4kg/cm<sup>2</sup> pressure. Anchoring of the cladding wall was done using 25mm dia. steel bars up to 6 m depth (staggered) at 2.5m c/c spacing.

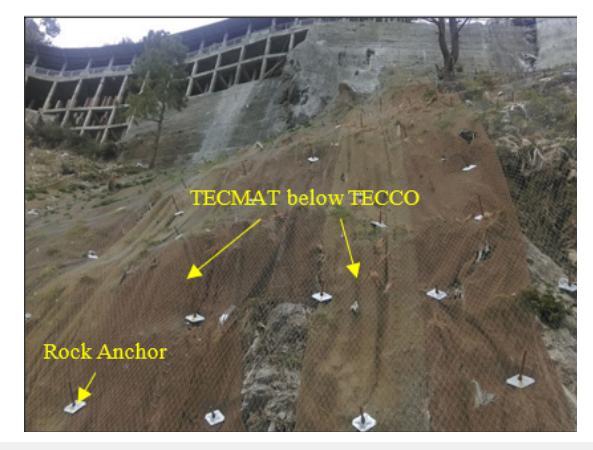
Figure 2: Treatment of location-3 slope by applying TECMAT below TECHO and rock anchors.

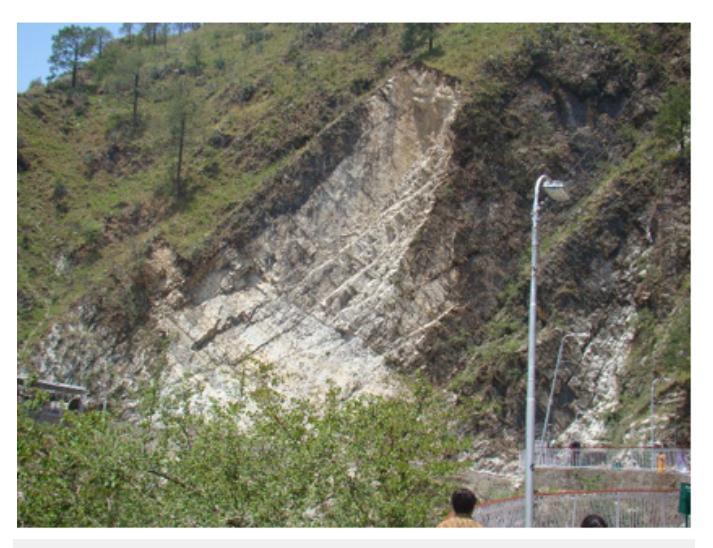
Location no. 7 is located between Ardhkuwari and Mata Bhawan (new track) at chainage 0.925 to 1.000km. The major geological discontinuities mapped are: (i) bedding - N140° (strike)/45° (angle of dip)/N50° (dip direction), (ii) J1 - N240°/65°/N150° and (iii) J2 - N135°/65°/225°. Average slope angle is 70° towards N150°. The rocks are well traversed by three sets of joints i.e., B, J1 and J2, each being nearly perpendicular to each other (Figure 3). The slope direction being N150°, the joint J1 controls the slope being parallel to it. The bedding and joint J2 act as release joints. High energy absorption rockfall barriers, shotcrete, drainage holes and consolidation grouting treatments were applied for this slope (Figure 4). 100mm thick shotcrete in 2 layers with chain link mesh was applied on the rock surface after cleaning of slope from Ch. 0.890 to 0.950km, between El. 1470 to 1570m. Aluminium saltbased white powder accelerator (MasterRoc SA 540) was used to reduce the rebound. The chloride ion content in this white powder was <0.1 percent and bulk density was between 500-700kg/m<sup>3</sup>. One stage consolidation grouting through 38mm dia. holes up to 10m depth at 3m c/c spacing (staggered) was done from chainage 0.900 to 0.940km., between El. 1520 and 1570m. 40 numbers of drainage holes of 76mm dia. and 10m deep are provided from Ch. 0.890 to 0.950km at 6.0m c/c spacing (staggered) from El. 1470 to 1500m. Tension cracks were filled and sealed by cement

Figure 3: View of location-7 slope before treatment.

slurry. In this location, at 4 places, rockfall protection barriers are constructed. Two numbers (profile number 1 & 3) of 6m high and 40m long each, rockfall barriers of minimum energy absorption in the entire system of 5000K.J. are constructed at El. 1475m and 1540m. Two numbers (Profile 2 & 4) of 5m high and 30m length each, rockfall barriers of minimum energy absorption in the entire system of 3000K.J. are constructed at El. 1490m and 1580m.

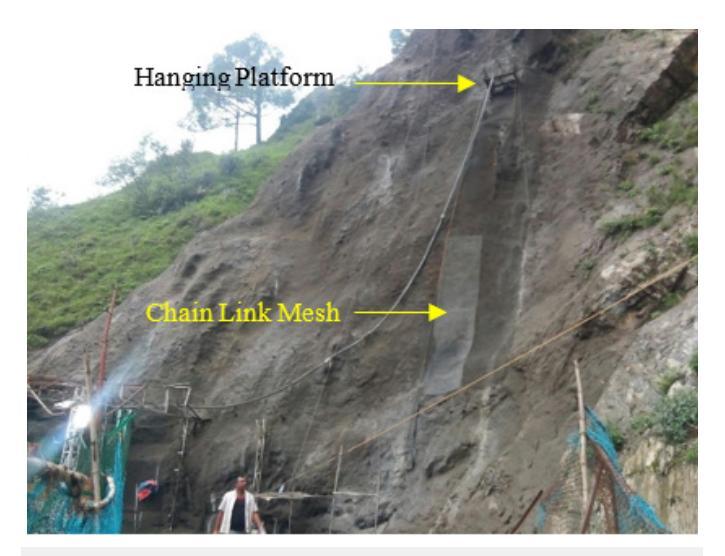
Figure 4: In location-7 two layers of shotcretes were applied along with chain link mesh.

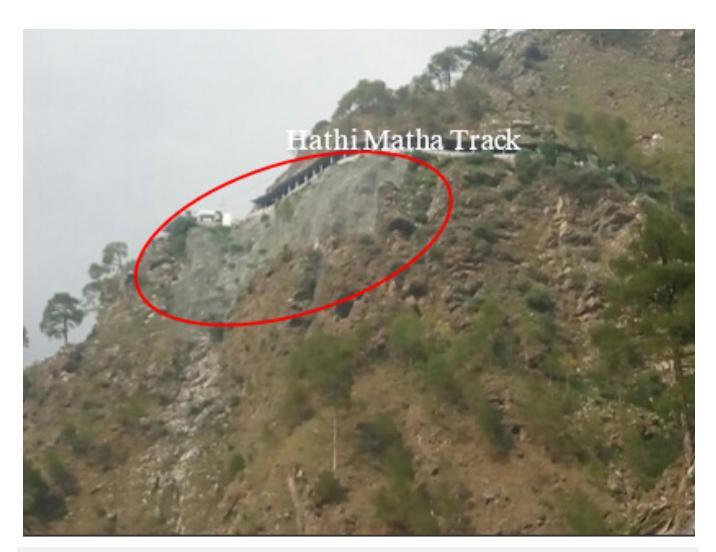
Location no. 14 is located between Ardhkuwari and Mata Bhawan (new track), just before Panchhi staff colony at chainage 3.850 to 4.250km. At site-14 limestone exposed in the area is well jointed with well-developed bedding planes. The rock was weathered close to the surface making to discontinuities to open up and making rock wedges more unstable and loose in nature. In view of closely spaced beddings, the resultant rock wedges were small in nature. They stick to the surface due to secondary cementation. The discontinuities mapped are: (i) bedding - N310° (strike)/35° (angle of dip)/N40° (dip direction), (ii) J1 - N50°/65°/N320° and (iii) J2 - N350°/60°/260°. Average slope angle is 50° towards N290°. The bedding dips askew to the direction of slope. But the rock wedge formed due to joints J1 and J2 has a plunge towards the direction of the slope, but with nearly 15° difference. Hence, it is a potential wedge to cause wedge failure. But since the plunge amount is more than that of the slope, it will be ineffective to cause any actual wedge failure. High energy absorption rockfall barriers and high tensile rolled cable net with anchors were applied for this slope. At two places, QUAROX above secondary mesh was applied to hold the fractured rock mass on the cliff area (Figure 5). QUAROX was anchored with full column grouted (1:1 sand & cement), 6.0 m length and 28mm dia. anchor bolts at a spacing of 3.0m c/c in staggered fashion. Dia. of hole for anchor bolts was 90mm. In an 1875m<sup>2</sup> area high-tensile rolled cable net was applied. 5m high and 60m & 50m long rockfall barriers at profile no 1 & 3 respectively, of minimum energy absorption in the entire system of 3000K.J. are constructed at El. 1675m and 1690m (Figure 6). 9m high and 25m long rockfall barrier at profile no 2 of minimum energy absorption in the entire system of 8000K.J. is constructed at El. 1680m. 6m high and 20m long rockfall barrier at profile no 5 of minimum energy absorption of 5000K.J. is constructed at El. 1710m. 7m high and 30m long rockfall barrier at profile no 4 of minimum energy absorption of 5000K.J. is constructed at El 1670m. Gaps between the rockfall barriers and rock surface were properly plugged by proper installation of net and anchors.

**Figure 5:** Treatment of location-14 slope by applying QUAROX with secondary mesh and rock anchors.

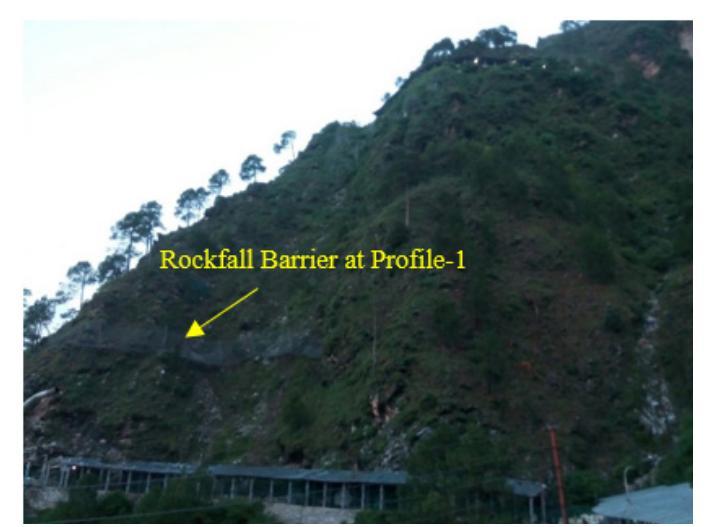
Location no. 16 is located between Ardhkuwari and Mata Bhawan (new track), before battery cars stand at chainage 5.075 to 5.375km. At location-16 area, hard and more massive rocks are exposed in the area on steep to vertical slopes. Overhangs are seen on the slope just above the pathway formed mainly due to excavation of the bottom slopes. Since the rocks are weathered close to the surface, the intersection of joints and closely spaced bedding planes within the rocks had resulted in the formation of many small rock wedges, which lie nearly loose on the surface. The discontinuities mapped are: (i) bedding - N305° (strike)/55° (angle of dip)/N35° (dip direction), (ii) J1 - N330°/45°/N240° and (iii) J2 - N20°/70°/290°. Average slope angle is 75° towards N325°. All the geological discontinuities dip in different directions as compared to the slope. However, many of the rock wedges formed due to intersection of these discontinuities dip in the direction of the slope. Except the intersection by J1 and B the other intersections have their direction of plunge more than 20° as compared to slope direction. Only the direction of the plunge of intersection by J1 and B is very close to the direction of the slope, but the plunge amount is too low (about 15°) to cause a landslide. Treatment applied for this slope are high energy absorption rockfall barriers, high tensile rolled cable net with anchors, anchor bolts and drainage holes.

Figure 6: View of 5m high, 60m long rockfall barrier built at El. 1675m.

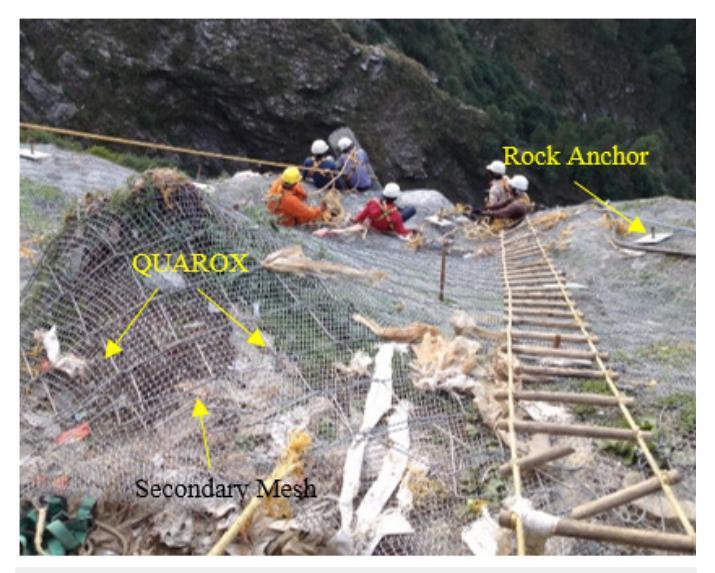
**Figure 7** : Treatment of location-16 slope by applying QUAROX with secondary mesh and rock anchors.

At two places, QUAROX above secondary mesh was applied in an 1800m<sup>2</sup> area to hold the fractured rock mass (Figure 7). QUAROX was anchored with full column grouted (1:1 sand & cement), 8.0m long and 28mm dia. anchor bolts at a spacing of 2.0m c/c in staggered fashion. Size of hole was 90mm dia. for grouted anchor bolts. In other areas wherever required, 25mm dia., 6.0m long grouted rock anchors were installed and the dia. of hole was 50mm. Wherever required consolidation grouting through 38mm dia. holes up to 10m depth were done at one stage. 15 numbers of drainage holes of 76mm dia. up to 10m depth are drilled between Ch. 5.150 and 5.200km. 6m high and 30m long rockfall barrier at profile no 1 of minimum energy absorption of 5000K.J. is constructed at El. 1770m. 5m high and 55m long rockfall barrier at profile no 2 of minimum energy absorption of 3000K.J. is constructed at El. 1785m (Figure 8). 6m high and 40m long rockfall barrier at profile no 3 of minimum energy absorption of 3000K.J. is constructed at El 1820m. 6m high and 30m long rockfall barrier at profile no 4 of minimum energy absorption of 3000K.J. is constructed at El 1830m. Gaps between the rockfall barriers and rock surface were properly plugged by proper installation of net and anchors.

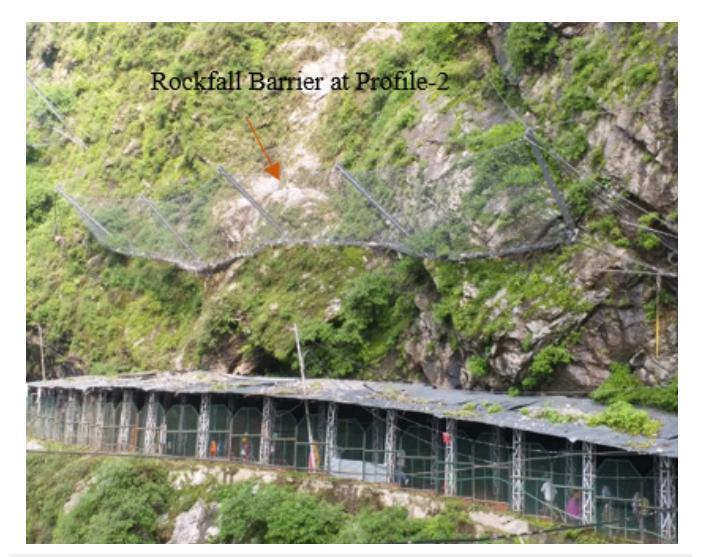
Figure 8: View of 5m high, 55m long rockfall barrier built at El. 1785m.

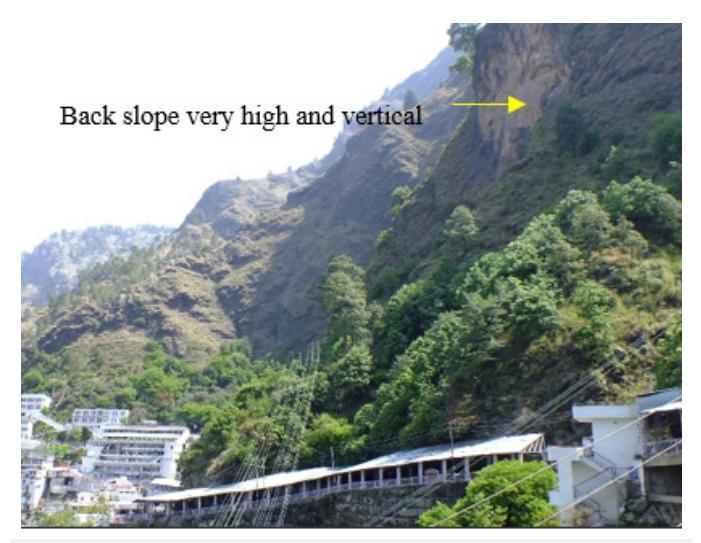
Location no. 17 is located between Ardhkuwari and Mata Bhawan (new track), 100m from Manokamna Bhawan & 50m from Junction of Old and New Trek at chainage 5.450 to 5.525km. At location-17 rocks are not exposed in the area near the footpath track. A thick debris cover is seen on the entire slope in the area. The slope has a number of dislocated rock blocks seen scattered on the slope. The toe retaining wall provides effective support for the debris lying above. The backside slope is nearly vertical and extends to a very large high (Figure 9). This area is protected with two high energy absorption rockfall barriers. At this location, a 6m high and 25m long rockfall barrier at profile no 1 of minimum energy absorption of 3000K.J. is constructed at El. 1790m (Figure 10). 7m high and 25m long rockfall barrier at profile no 2 of minimum energy absorption of 5000K.J. is constructed at El. 1765m. Gaps between the rockfall barriers and debris are properly plugged with gunny bags filled with sand. The site conditions prohibit implementation

Figure 9: View of back slope, which is vertical and very high.

of other measures except what has been provided. Additional chain link fabric along the systems has been provided by SMVDSB as an additional safety feature.

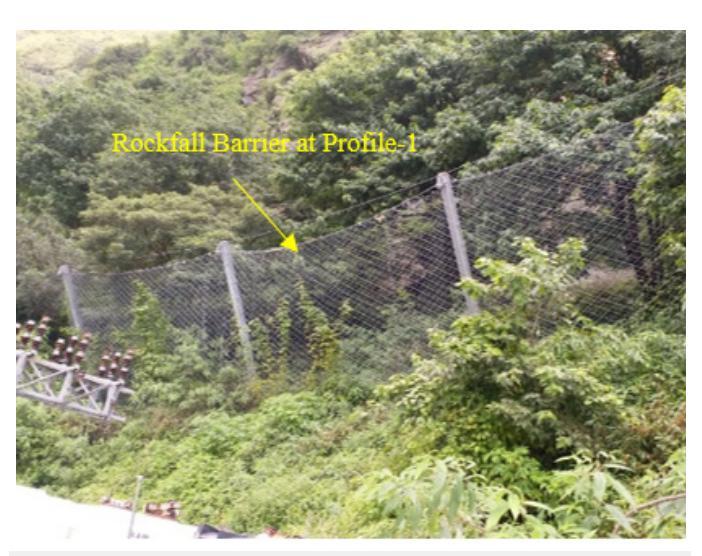
Figure 10: View of 6m high, 25m long rockfall barrier built at El. 1790m.

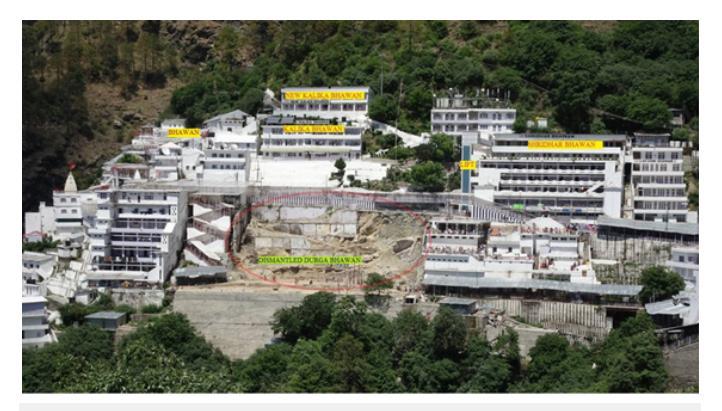
Figure 11: View of dismantled Durga Bhawan before treatment.

At about 13:30 hours on 12th March 2016, track between elevator point and gate no. 5 at Bhawan got damaged due to heavy and continuous rain which led to landsliding. Aged Durga Bhawan building had to be dismantled for construction of a new Bhawan and because of this existing toe support was disturbed. Slope failed near the dismantled Durga Bhawan, taking away about 22m part of the footpath and it was very hazardous for the movement of pilgrims (Figure 11). Immediately after this incident, a site was visited and keeping in view the importance of the Bhawan area and the convenience of pilgrims, as an immediate measure, 6m & 10m deep drilling for consolidation grouting was started to consolidate the rock mass which in turn checks further damage to the track and nearby area. 20 boreholes were drilled, 10nos. were 6m deep and balanced 10m deep (Figure 12). A proper assessment was done and a stretch of 58m was identified as vulnerable. For the long-term stability of the Bhawan area and the structures located above the slope, anchored cladding wall along with RCC retaining wall with pre-stressed cable anchors were proposed, designed and constructed (Figure 13). At the base, a 100mm thick levelling course of M-10 grade was made and above this 500mm thick M-20 raft was constructed. Width of footing was between 3500 and 4000mm. Raft was anchored with fully grouted 25mm dia. rod at 1500m c/c spacing (6m in rock and 1m in concrete). Above the raft, a 6.0m high of M-20 concrete cladding wall was constructed. Cladding wall was anchored with fully grouted 25mm dia. rod at 2500m c/c spacing (6m in rock and 3m in concrete). 100mm dia. MS drain pipes inclined at 10° at 2400mm c/c spacing at every lift of concrete (staggered) in the cladding wall were installed. Lift height was 1500mm. 6.60m high RCC wall of M-25 grade was constructed above the cladding wall. RCC wall footing was anchored with two rows of anchors of fully grouted 25mm dia. rod at 2500m c/c spacing (6m in cladding/rock and 1m in concrete). 100mm dia. MS drain pipes inclined at  $10^{\circ}$  at 2400mm c/c spacing at four elevations (staggered) in the RCC wall area were installed. 200mm dia. MS pipe normal to the foliation plane for cable anchors at 1500mm c/c were installed. In the RCC wall area, back filling was done with plum concrete. The RCC wall was anchored with prestressed cable anchors of 100 T capacity and depth varying from 26.5m to 30.5m and a total of 1088.5R/M anchoring was done through 37 drilled

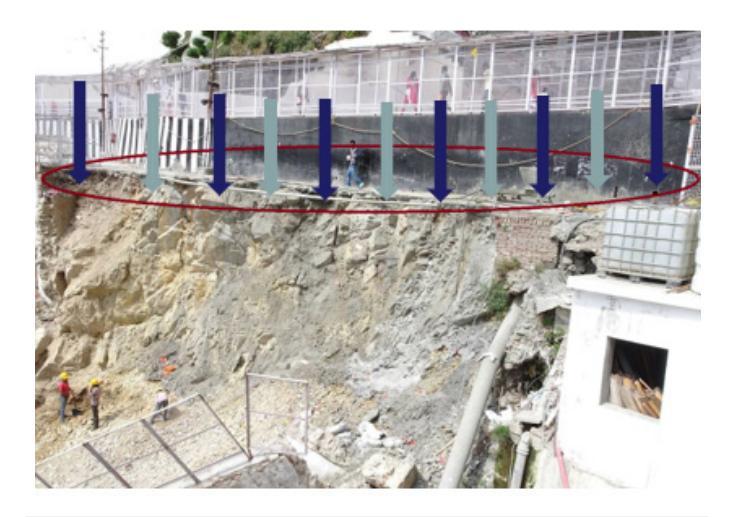
Figure 12: Location of consolidation grouting.

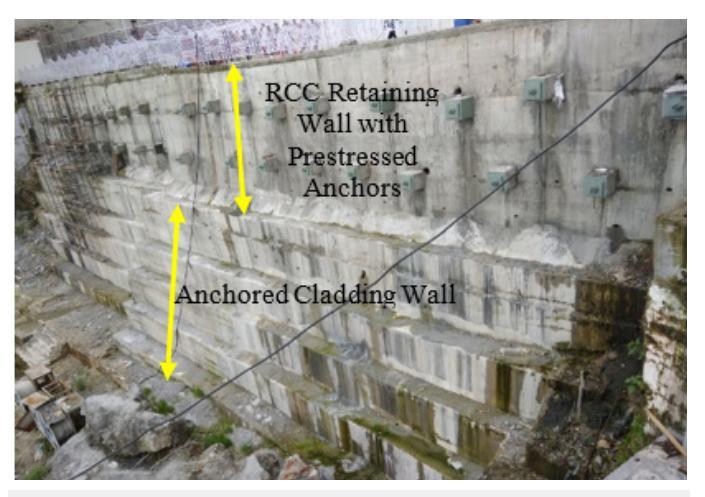
Figure 13: Restoration track at Durga Bhawan.Table 1: Description of major work component.

holes. 26 anchors are of 30.5m length while 11 numbers of 26.5m length. For prestressed cable anchors, high tensile strands (seven ply strand) conforming to IS-14268 class 2, manufactured by Usha Martin Ltd were used [6]. This whole process leads to building a monolithic structure capable of resisting active as well as passive loads on slope. The major interventions involved under the scope are given in Table 1. The technical specifications for some of the major components are given in Table 2.
