Wound Treatment Assessment with Three-Dimensional Planimetry Scanning and Images in Multifrequency Light- A Case Report

Rita I Sharma^{1*}, Jacek Kot^{1#}, Piotr Tojza^{2#}, Leszek S Litzbarski^{2#} and Grzegorz Redlarski^{2,3#}

¹National Centre for Hyperbaric Medicine, Institute of Maritime and Tropical Medicine in Gdynia, Medical University of Gdansk, Poland

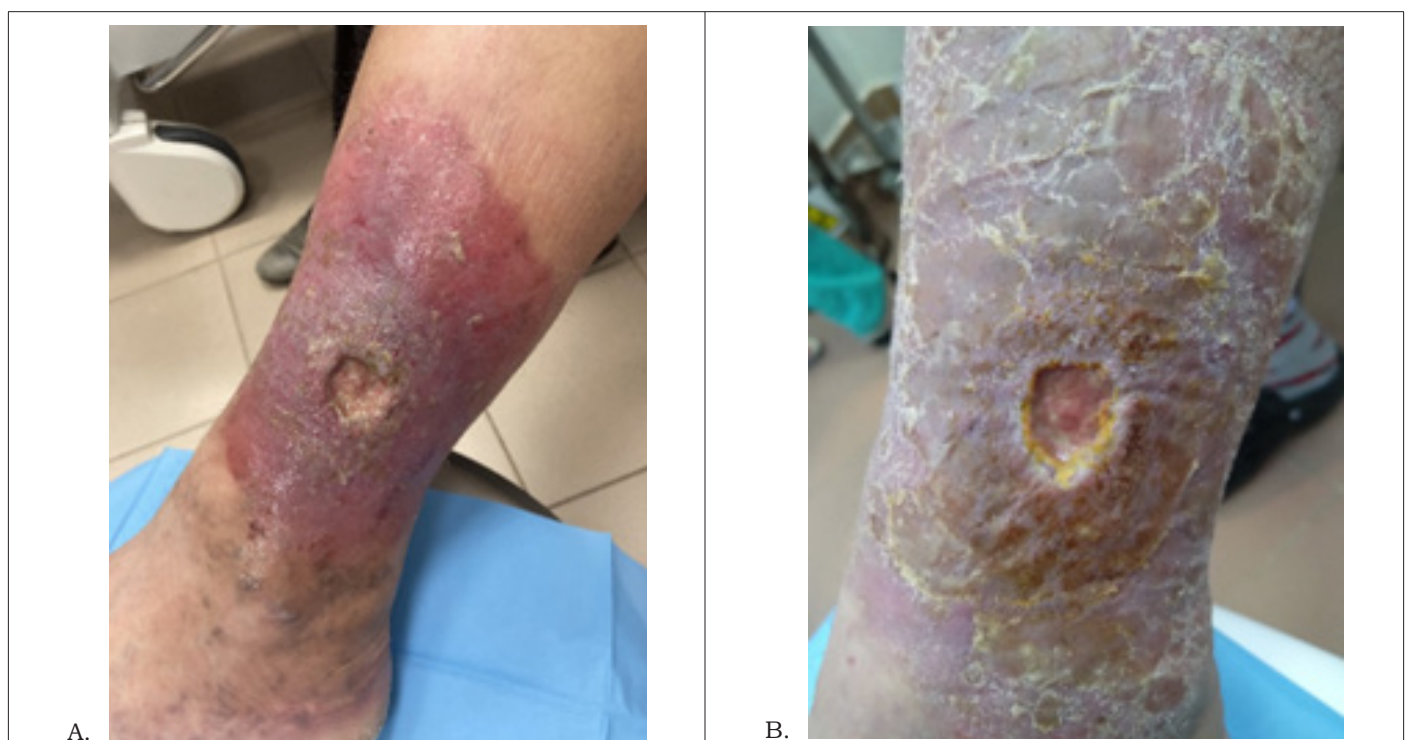
Table 1: presenting wound photographs before (A) and after (B) the treatment in multifrequency light.

After being referred to the surgeon, he got back after debridement for re-consultation. The patient was qualified for hyperbaric oxygen therapy consisting of 30 sessions (2.5 ATA. 100% oxygen plus air breaks). The wound was documented with three-dimensional scanner and images in ultraviolet and infrared light (Table 1).

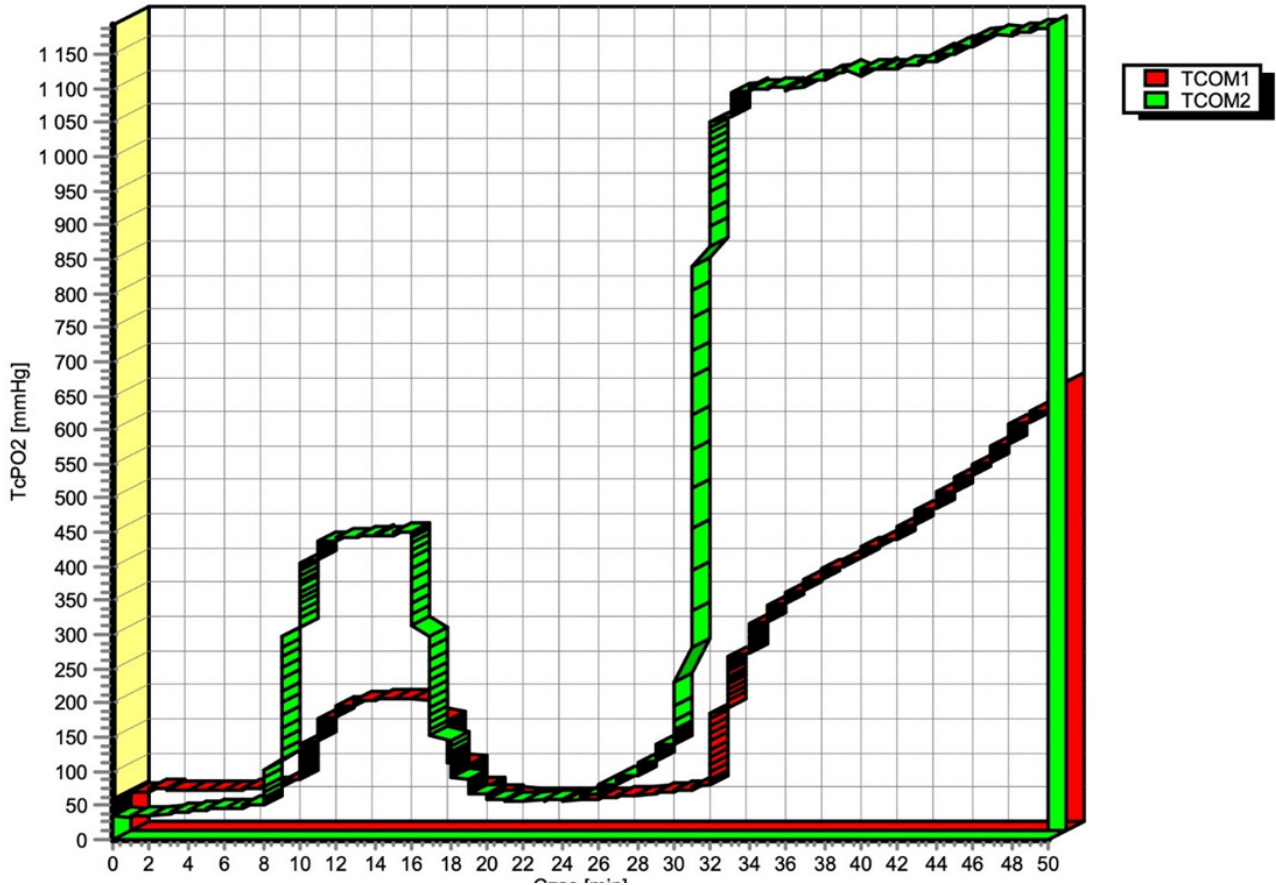
Chart 2: (TcPO₂- transcutaneous pO₂ [mmHg]; time [min]; TCOM 1- electrode near the wound, TCOM 2- reference electrode placed in subclavian area).

Results of transcutaneous oximetry showed pO₂ 60 mmHg with an increase during HBOT to 1150mmHg, what proves satisfying tissue response to hyperoxia and relates to high-healing potential (Chart 2,3). First data taken on 28th July 2023 at the begging of hyperbaric oxygen therapy documented primary wound dimensions. After almost one moth of HBOT we documented again

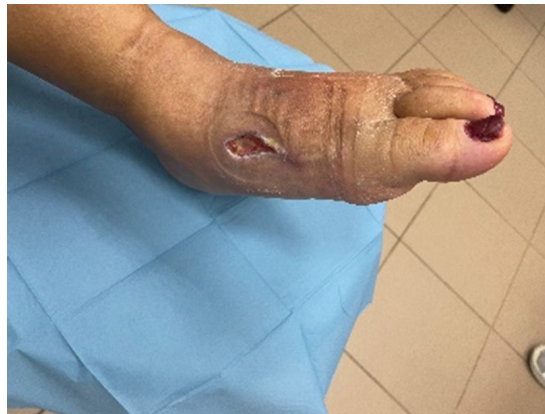
Table 2: presenting wound photographs before the treatment in multifrequency light.

mainly in tarsometatarsal joint. Despite conservative treatment, she suffered from phlegmon that was surgically incised and underwent targeted antibiotic therapy. As the wound did not heal, she was referred for hyperbaric consultation. The wound was estimated with the size 4x2cm located on the medial part of left forefoot; no necrotizing tissues observed. The patient used dedicated dressings including silver dressings. During first consultation photographic documentation was done (Table 2).

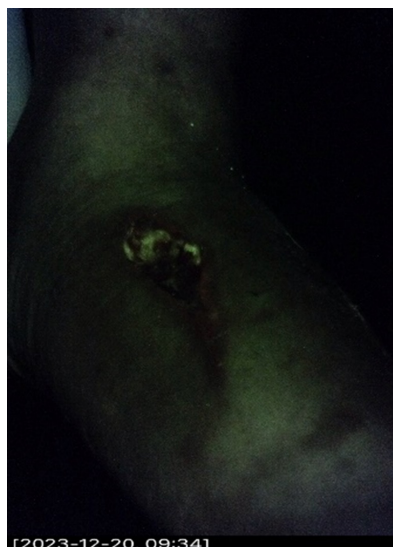
Photographs in ultraviolet light (below)
