Internal Pressure Capacity and Corrosion Behavior of Composite System Joining Metallic Pipes

This paper examines the effect of fiber-reinforced plastic (FRP) types on the internal pressure capacity and corrosion behavior of joined metallic pipes. To this end, fabrication processes of aluminum pipes have been prepared to be used later for wrapping with different FRP and welding. The FRP used are kevlar fiber/epoxy (KFRP) and carbon fiber/epoxy (CFRP). These fibers have been cut into strips and utilized in the joining systems using the fabric-winding method. Two types of pipes have been considered: pipes joined with four layers of KFRP and pipes with eight layers of KFRP-CFRP. On the other hand, pipes with two types of welding have been used for comparison purposes. The results showed improvement in the pipe's internal pressure capacity compared to welding. Finally, the corrosion test was carried out. The results showed that FRP joining systems have higher corrosion resistance than welded and non-joined pipes. These results revealed that using FRP composites in pipe joining shows a promising future.

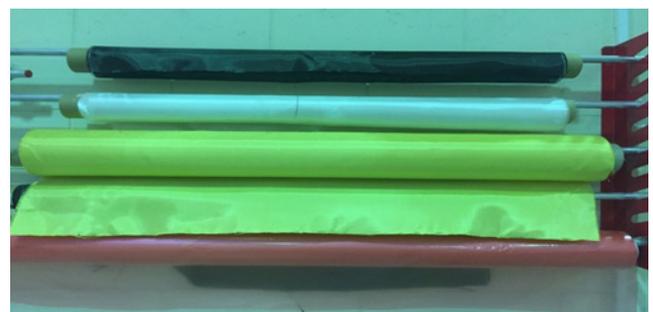
Figure 2: Woven sheets of fibers: kevlar fibers (yellow color) and carbon fibers (black color).

Two different types of fibers have been used: kevlar and carbon fiber. These fibers are in woven sheets form with 0°-90° see Figure 2.

Fibers preparation: All fibers (kevlar and carbon fiber) are in woven sheets, with 0° - 90° angles orientation. The woven sheets have been cut into long strips 5 cm in width. These strips have been cut with the same angle of 0° - 90° . Cutting with different angles has also been performed, but during the fabrication process, the trial for wrapping fibers with different angles failed due to fiber condensing and crushing; hence only a normal cut with 0° - 90° was successfully to be used in fabrication. These strips have been used in wrapping 0° - 90° as well as 45° - 45° by adjusting the angle of wrapping to 45° . Other angles have been difficult to wrap since they need manual adjusting for the angle when using 0° - 90° strips.

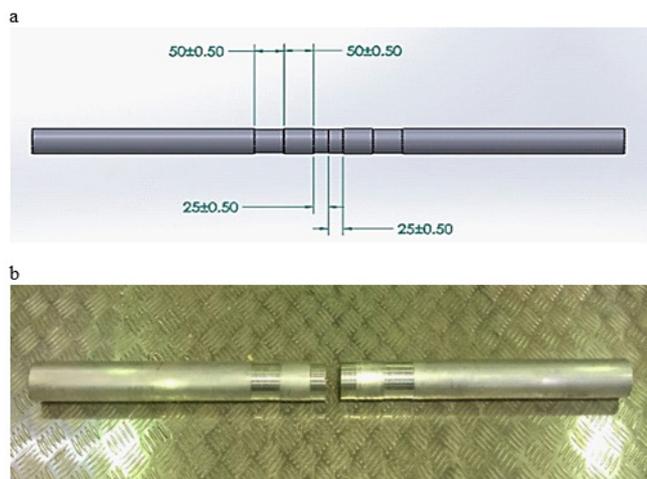
Figure 3: Aluminum pipe prepared for fabrication: (a) dimensions produced by Solidworks, and (b) sample after preparation.

Aluminum pipes for composite joining: Aluminum pipes of 1m total length have been cut in the middle, and the groove of 1.5 mm depth and 5 cm width has been applied, as shown in Figure 3, to allow for the wrapping process. A small solid cylindrical piece of aluminum has been used to mount the two parts of the pipes together for the wrapping process.

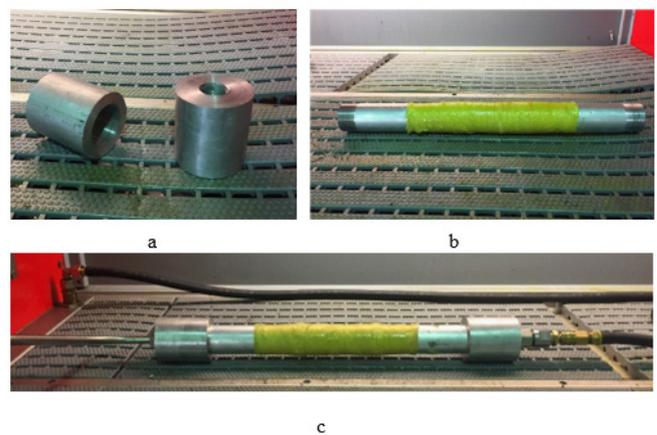
Figure 4: (a) fixtures, (b) a pipe with threads, and (c) pipe after fixation with inlet and outlet hoses.

The test has been carried out using Resato high-pressure machine model SPU-CC-2000. The reset machine applies pressure using corroded oil fluid pressurized by a high-pressure air pump with a maximum capacity of 2000 bar. The test starts with filling the pipe and then performing low pressure to ensure there is no leak before conducting the pressure test with 1MPa/min. After fabrication, the pipes delegated for the internal pressure test have been threaded from each side to fit in prepared fixtures for this test, see Figure 4. These two fixtures have been fabricated to allow the inlet and outlet hoses of the machine to be fixed to the pipes.

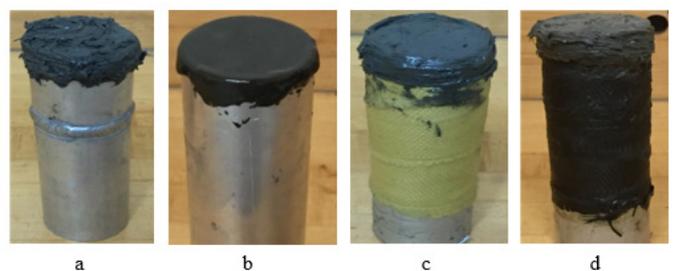
Figure 5: Aluminum pipe specimens before corrosion experiment: (a) welded aluminum pipe (b) non-welded aluminum pipe (c) aluminum pipe joined with KFRP(d) aluminum pipe joined with CFRP.

Corrosion investigation has been carried out on the two types of FRP composites joining (KFRP and CFRP) and the welded and non-joined pipes. First, the specimens were sealed from one side using chemical-resistant sealing. They were then immersed in 1.5M of HCL solution as corrosive media. The use of HCL is to imitate the severe environmental condition in the Gulf region, see Figure 5. In addition, to accelerate the corrosion process, a heater containing water at a temperature of 50°C has been used as a surrounding media to the solution, see Figure 6.

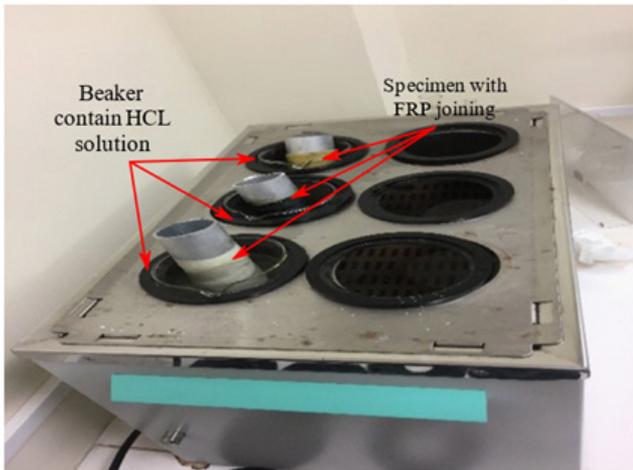
Figure 6: Beakers contain solution and specimens immersed in the heater.

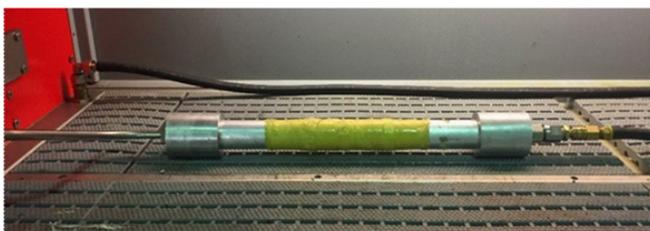
Figure 7: Aluminum pipes with KF joining under combined axial and radial internal pressure test.

The test for KF under combined axial and radial internal pressure test has been conducted by connecting both sides of the pipes with the inlet and outlet hoses using a cylindrical fixture, see Figure 7. The results showed that the pipe had been filling the stage for 16s before it experienced the cyclic internal pressure stage until failure after 4s with 100 bar of internal pressure, see Figure 8. The failure occurred when the leakage started. At the same time, the joint has been split from one side of the pipe without breakage in the main pipe body or the joint itself, see Figure 9. This indicates that the failure is related to resin failure in the layer in contact with the pipe surface. Accordingly, it has been decided to design another fixture to fix the pipe from each side to allow only radial pressure, giving a more realistic result and representing the reality where joined pipes are always fixed.

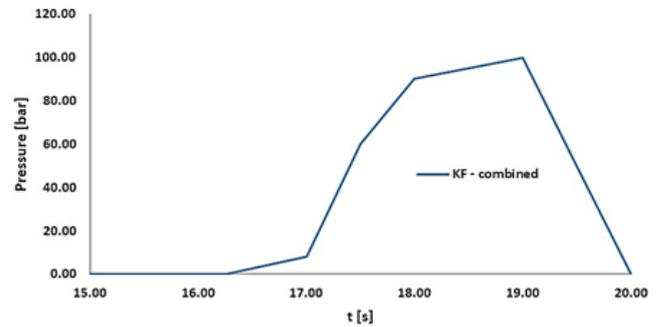
Figure 8: kevlar joining under combined axial and radial internal pressure.

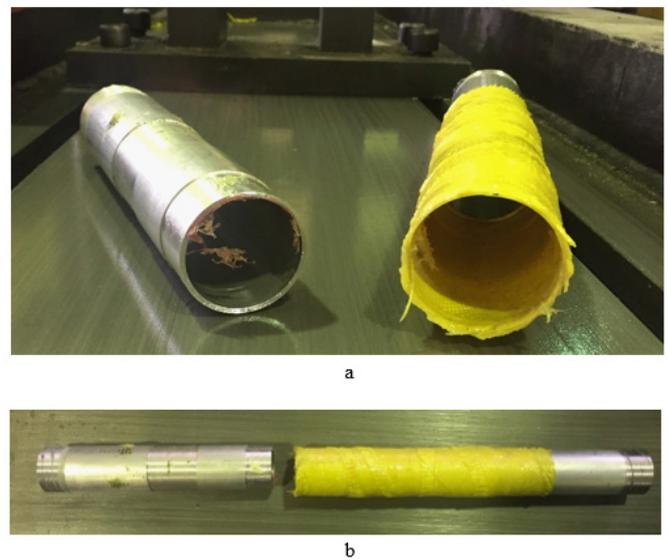
Figure 9: Split of the joint from the pipe.

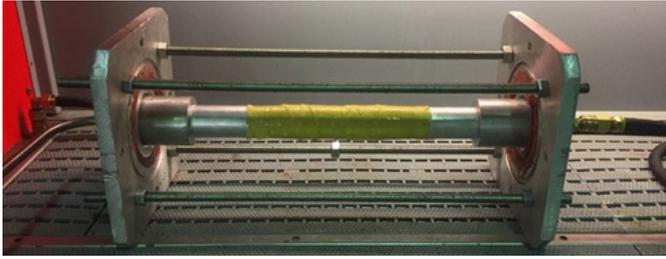
Figure 10: Fixation for radial internal pressure test.

For the radial internal pressure test, a new fixation has been used as a case to hold both sides of the pipe. This fixation has been designed as two plates connected using four long threaded rods with nuts for tiding. These two plates have a cup groove where the original two pipe fixtures can be placed, see Figure 10. The result of the KF under radial internal pressure test showed a significant increase in the internal pressure capacity of the pipe. The failure was observed at 200 bar after 30s from filling completion, see Figure 11. The failure occurred as leakage from the kevlar joint edges without any breakage or visual deformation in the pipe or the joint. Again, this failure is related to resin cracks in the layer, which is in contact with the pipe’s surface. After removing the pipe from the test fixtures, it was noticed that the joint was still connected to the pipe and could not be removed by hand.

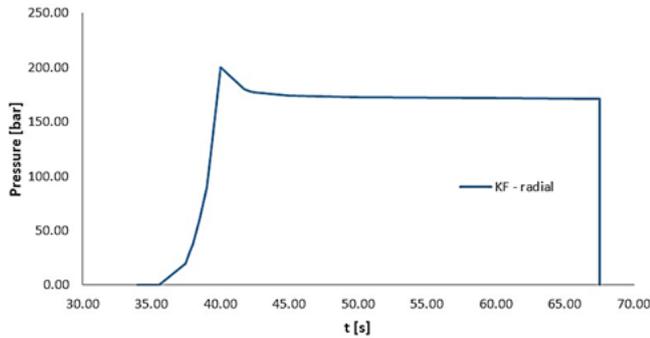
Figure 11: Kevlar joining under radial internal pressure.

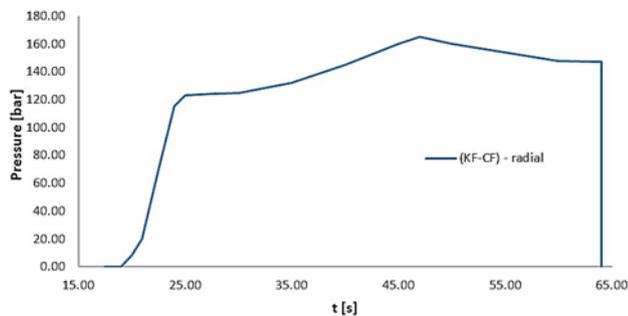
Figure 12: (KF-CF) joining under radial internal pressure.

As shown in Figure 12, the result of (CF-KF)-8 layers joined aluminum pipes under radial internal pressure test failed 160 bar after 40s from filling completion. The failure occurred as leakage from the composite joint edges, without any breakage or visual deformation in the pipe or the joint, as observed in KF-4 layers. Again, this failure is related to resin cracks in the layer, which is in contact with the pipe’s surface. After removing the pipe from the test fixtures, it was noticed that the joint was still connected to the pipe and could not be removed by hand. This result was lower than the results obtained from the KF-4 layers test, although it took a long time to occur. This finding can be referred to as hand lay-up problems during the fabrication process, including the amount of resin used. It indicates that the fabrication process quality could affect the results significantly.

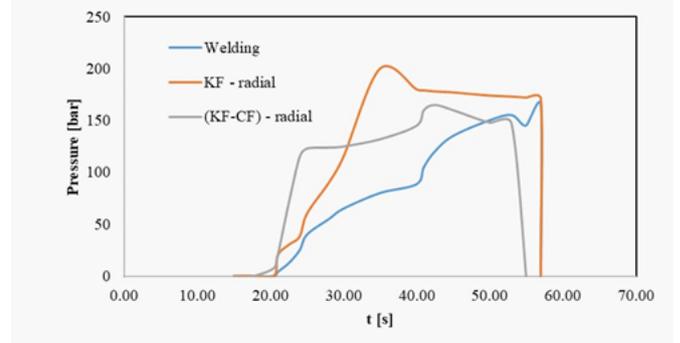
Figure 13: Internal pressure capacity of composite joining vs. welding.

The effect of fiber-reinforced composite: The results for welded aluminum pipe under radial internal pressure test showed

failure at 165 bar, see Figure 13. The KF-4 layers showed a higher internal pressure capacity of 200 bar. Although (CF-KF)-8 layers showed similar internal pressure capacity to welded aluminum pipe, it is believed that this behavior can be improved by higher quality in the fabrication process. In general, using composites for joining pipes shows a promising method for higher performance in terms of internal pressure compared to welding methods.

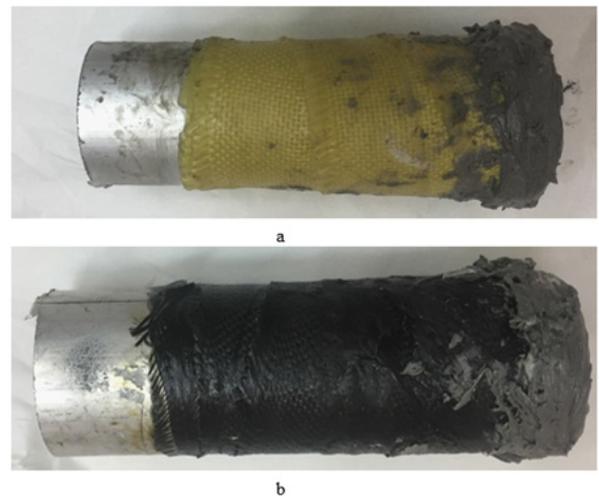
Figure 14: Aluminum pipe joined with FRP composites after one week of corrosion experiment: (a) aluminum pipe joined with KFRP, and (b) aluminum pipe joined with CFRP.

The experiment showed that corrosion was formed in welded and non-joined pipes. Figure 14 shows the aluminum pipe joined with FRP composites after one week of corrosion experiment where no corrosion was observed at the joining area. However, pitting corrosion started in both welded and non-welded aluminum pipes after one week of conducting the corrosion experiment, see Figure 15, due to acid attacking the oxide film on aluminum pipes.

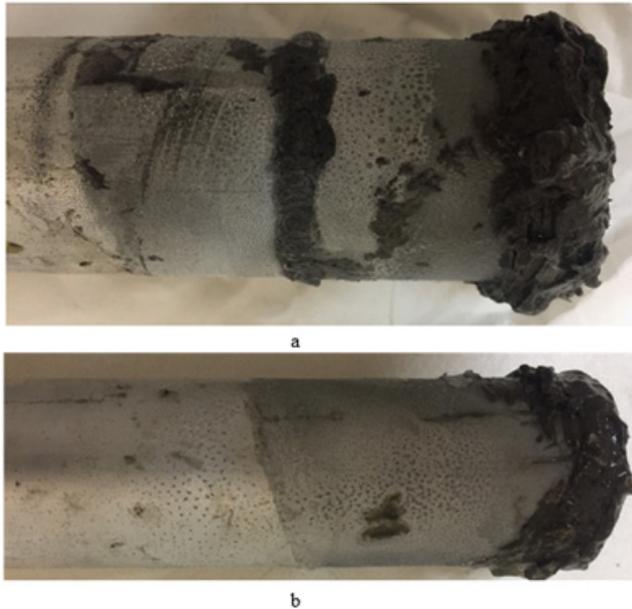
Figure 15: Corrosion in (a) welded and (b) non-welded aluminum pipe.
