Analysis of Factors Influencing the Fatigue Strength of Railway Fastening Clips

Presented paper characterized key factors influencing fatigue strength, including geometry, surface condition and chemical composition, as well as other parameters affecting the performance of railway fastening clips. Additionally, other technologies for improving the fatigue resistance are presented. The aim of the experimental part of the study was to evaluate the cause of the premature failure of a fastening clip during a scheduled fatigue test performed in accordance with the DBS 918 127 standard. A series of tests were conducted, including chemical composition analysis, microstructure examination, hardness testing, and fractographic analysis. Based on this research, it was concluded that the root cause of the premature failure was a particle embedded into the surface of the spring during the bending process.

Keywords: Rail fastening system; Tension clip; Fatigue strength; Cyclic load; Clip fatigue life

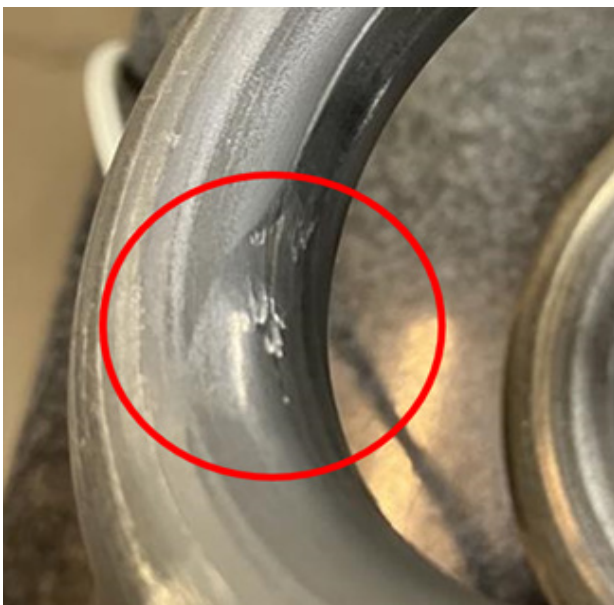
There are numerous studies describing the surface condition and fatigue strength of various products, including springs and leaf springs. Surface defects, including decarburization, as well as the presence of laps, seams, and other imperfections, lead to premature spring failure (Figure 4). A key aspect of this process is the surface quality of the worked component, as any tool marks left during processing can act as stress concentrators. Such micro-scratches and surface irregularities weaken the material structure, increasing the risk of fatigue cracks and reducing the component's service life. Therefore, proper selection of tools, their technical condition, and precise control of process parameters are crucial to minimizing the risk of surface defects. To address these issues, a grinding or draw-peeling (shaving) process of the outer layer of spring wire is used to improve its quality [11,15].

Figure 4: Bending marks on the surface of clip [1].

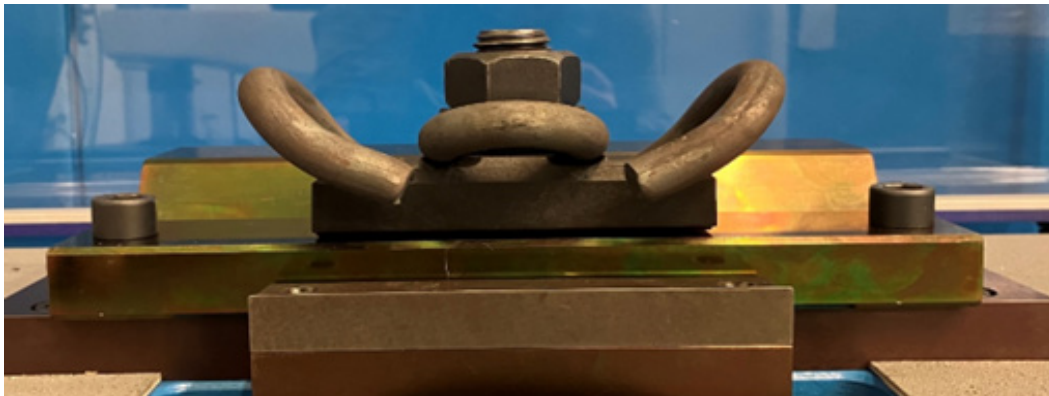
[9]. The graph presents two curves representing the upper and lower amplitude positions, along with the corresponding forces at the peak and trough of a 2mm peak-to-peak amplitude. The fatigue test setup consists of a fatigue testing machine, a metal profile simulating a sleeper, and a WFP12K12 angle plate. The traverse is placed at the bottom and has an end that simulates the sleeper. The test setup fully replicates the railway system (Figure 6).

Figure 6: SKL14 fatigue test setup [1].
