Managing Cracks in Large Concrete Coffee Drying Yards

Fairbairn EMR^{1*} and Moura RPM²

This paper presents a case study on the construction of a concrete patio for drying coffee in the Mantiqueira range, state of Minas Gerais, Brazil. It is demonstrated that the appearance of cracks in a structure of this type is inevitable. A “chessboard” construction scheme was then used in which the cracks will appear at the weakest point, which is the point where the “black and white squares” touch each other. No materials were used to create expansion joints, as they naturally appeared without the need for wooden or plastic strips. The use of such strips could compromise the proper functioning of the yard due to their aging. Crack opening was calculated for the standard cell. After construction, the calculation hypotheses were verified, and the yard has been regularly used for drying coffee beans since 2016.

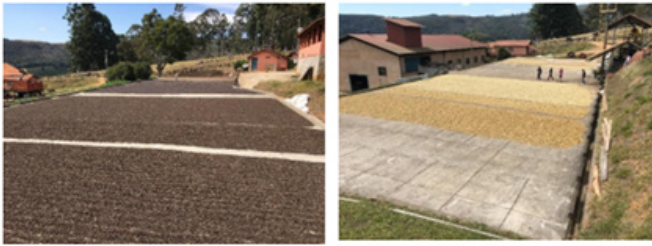
Figure 1: Coffee drying in concrete patios (Trapiá Farm in the Mantiqueira Range, MG, Brazil).

In the coffee-growing regions in Brazil, coffee beans are typically dried in the sun on large concrete patios (Figure 1). The engineering used to build these patios is not very sophisticated, basically using traditional techniques without great technological control. To prevent uncontrolled cracking of the concrete, square plates are defined by placing wooden joints at regular intervals. However, over time, the wood rots, and leaves voids where coffee beans can become lodged. As a result, these beans can begin to rot and cause further issues (Figure 2). Instead of using wooden slats, other solutions can be envisaged such as using thinner and more durable plastic bars. However, plastic bars subjected to the weather variations (sunshine, rain, strong ambient temperature gradients) also age and become brittle. This article proposes a solution to this problem using straightforward techniques that are based on traditional regional techniques and verified through fundamental concepts in the mechanics of cementitious materials. As the properties of the materials could not be determined through laboratory analysis and the construction techniques are handmade, the magnitudes of the properties of the materials involved in solving the problem were estimated based on common sense and bibliographical references. The solution was applied to a coffee drying yard on a coffee plantation farm in the south of the state of Minas Gerais in Brazil. The crack openings were measured, and it was verified that the order of magnitude was the same as the calculated one. It was verified that the drying yard fulfills its role, and the construction is carried out in a very simple way with the use of unskilled labor and unsophisticated equipment.

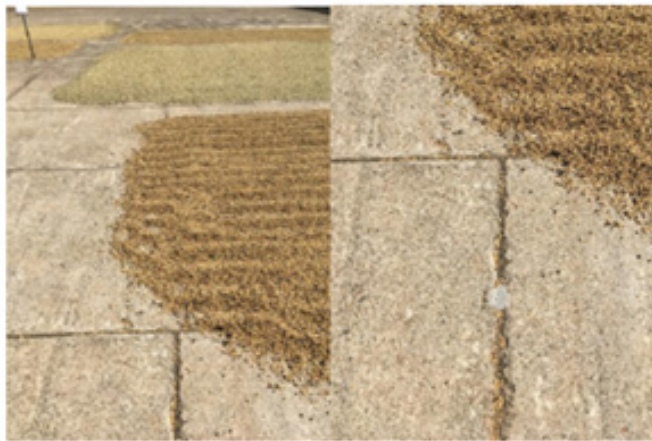
Figure 2: Rotten wooden joints with coffee beans in the voids.

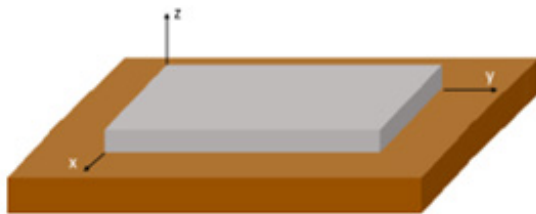
Figure 3: Idealization of concrete floor on the ground.

appear and evolve according to the loads imposed on the structure [2]. Considering that no stresses can develop in the z axis of the floor (Figure 3), and that the distortions are negligible, the plane stress equations for linear elastic material can be written as:

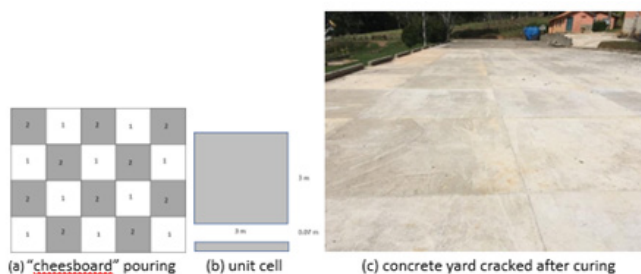
Figure 4: “Chessboard” concrete pouring.

Equation (3) indicates that the calculated stress is much greater than the tensile strength. This means that even if the values of the parameters that characterize the restrictions (boundaries), the concrete and thermal variations are erroneously estimated, cracking will inevitably occur. In any case, the stresses originated by each of the deformations taken separately (drying, autogenous and thermal shrinkage) would be sufficient to crack the concrete. In view of the inevitability of cracking (see, for instance [4]), the main idea is that expansion joints will not be made at all (whether with wood, plastic, or other material), but that cracking will be induced to occur in predetermined places. For this, a traditional, regionally performed technique was employed, whereby concrete was cast in the form of a “chessboard”. Following this method, the “white squares” were poured first, with the “black squares” added at a later stage (Figure 4a). In this way, cracks will appear at the weakest points of the structure, namely on the vertical surfaces where the “white” and “black squares” touch. It is now necessary to verify whether the crack openings will be compatible with the use of coffee drying patios. A simple calculation indicates that an approximate value can be obtained by multiplying the imposed strains (upper-bound) by the edge size of the square, which is 3m (Figure 4b). This gives a relative displacement between squares of:

The yard was built with non-reinforced concrete and the cracks appeared exactly in the points where they were expected as indicated in Figure 4c. The cracks showed an opening of the order of magnitude of 2mm as predicted, being compatible with the use of patios for drying coffee beans (Figure 5). The cracks have an opening that does not allow the penetration of coffee beans.

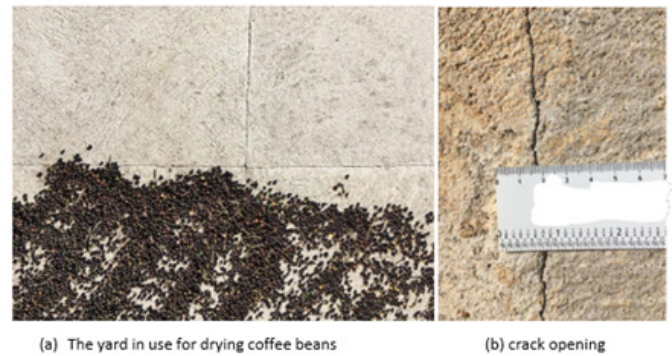
Figure 5: Cracks in the concrete patio.
