# Critical Issues of Sustainability Associated with Quarry Activities

Nwachukwu MA\*, Ojeaga K and Gilbert Chinelo

Department of Environmental Technology, Federal University of Technology Owerri, Nigeria

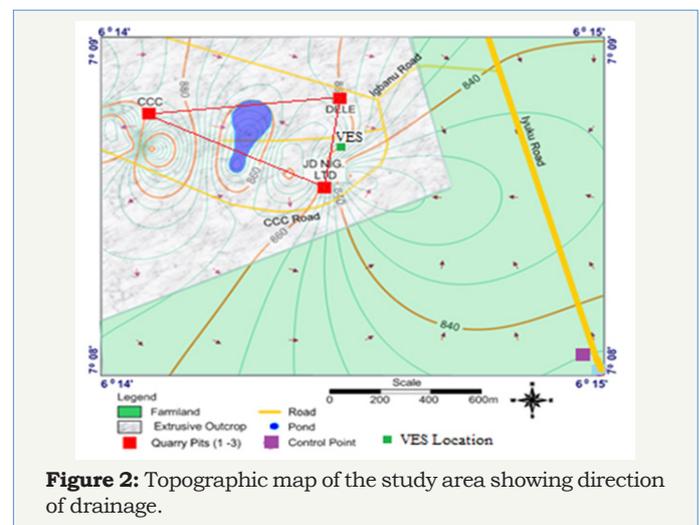
**Figure 2:** Topographic map of the study area showing direction of drainage.

Figure 2 depicts the topographic map of the study area. It indicates that there is no well-defined direction of drainage (surface runoff) within the study area. This is due to topography and truncated landscape with surface granite rocks often obstructing drainage in the area. The elevation of the study area above mean sea level ranges from 920ft to 835ft. From photo imagery, the ash colored areas represents the igneous outcrop whereas areas with green color represent farmlands. The farmlands have gentle slope represented by evenly spaced contour lines whereas the areas with the outcrop have steep slope represented by close spaced contour lines. Areas of lower elevation represent the normal ground level (exploited area). The people of the areas are mainly farmers who depend on the clayey weathered top soil, which the farmers confirmed as excellent in crop production.

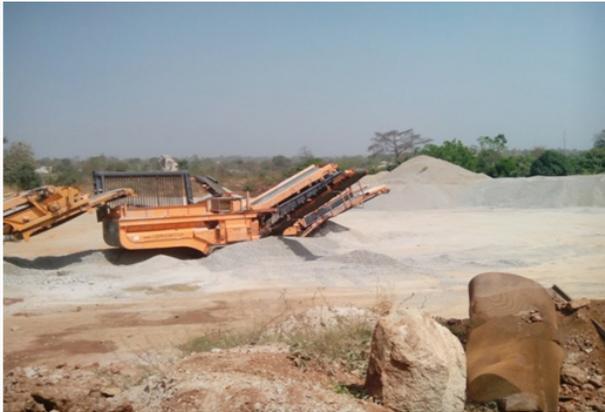
**Figure 3:** CAT E650 Crusher plant at work in Julius Dinga Quarry.

Preliminary investigations revealed that quarry equipments such as excavators, crusher plants, haulage trucks and the use of explosives during rock blasting generates significant amount of vibrations, noise and dusts that impacts the environment (Figure 3). Different sizes of boulders can be found along-side the massive deposit of the granite (Figure 4). Residents of Iyuku community confirm that these vibrations and noise have destroyed

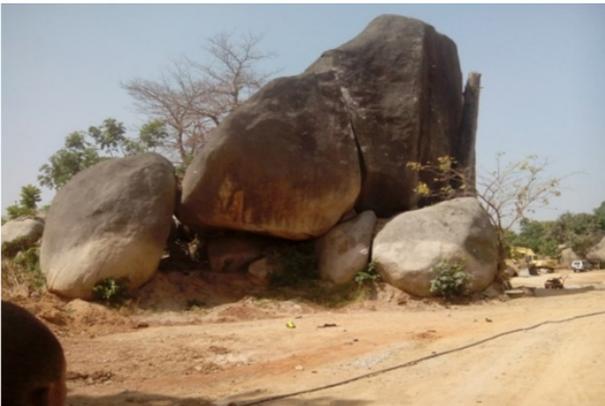
**Figure 4:** Surface exposed boulder rocks at Iyuku, Auchu, Edo state.

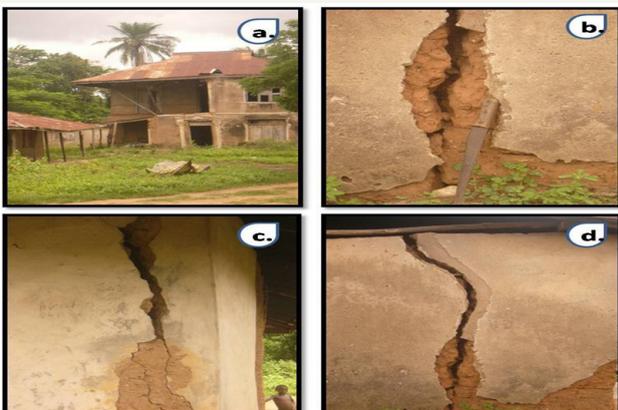
**Figure 5(a-d):** Indicates different degree of cracks caused by vibrations at Igbenu, Iyuku.

some buildings, cause discomfort to the ears of residents, and displacement of biodiversity particularly birds. Findings show different degrees of cracks on the walls of buildings (Figure 5). Community members and quarry workers complained that they sometimes feel a ringing sound in their ears that deprives them of quality sleep. They also reported difficulty in hunting, as most animals particularly antelopes have migrated from the area to more distant areas.

of vibrations, noise and fugitive dust particles that impacts the environment. The vibrations and noise generated have affected buildings, humans and biodiversity in the area. Findings show different degrees of cracks on the wall of residential buildings causing collapse. These cracks are mainly due to seismic waves released by seismic sources (Explosives) during rock blasting. These seismic waves create strong vibrations within the vicinity of the blast. The partially collapsed buildings threaten the lives of humans and livestock that live in them. Collapsed buildings in the area do not only affects humans and biodiversity but result in loss of scarce economic resources.

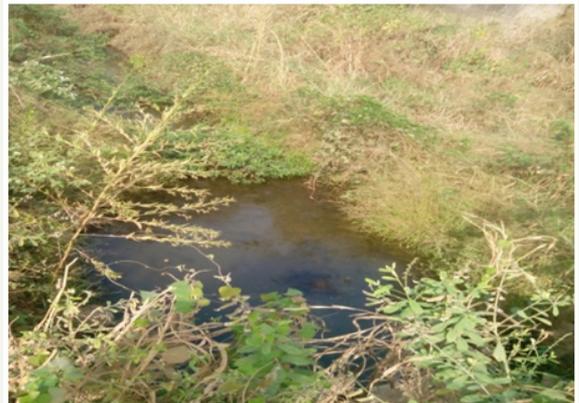
An abandoned quarry pit turned pond within the quarry sites (Figure 6) is responsible for the high rate of mosquito and tsetse flies in the area. The abandoned pit turned pond has the characteristics of contaminating groundwater. Investigations show that none of the three active quarries in Iyuku has fully complied with safety rules. Perimeter fences were not constructed in any of the quarries and danger signs were conspicuously absent within the vicinity. Only a few quarry workers at Julius Dinga quarry Ltd were seen wearing ear muffs and nose masks to reduce the effects of noise and dust. Figure 3, piles of fine aggregates for asphaltting produced by CAT E650 crusher plant at Julius Dinga quarry are continuously exposed to surface environment. Heavy rain falls wash the crushed rock and drain to farm lands and nearby water ways. Figure 5 (a-d) shows the impacts of quarry activities on residential buildings around Iyuku. These visible cracks on buildings threaten community residents. These cracks are produced from the continuous use of explosives, quarry equipments, and haulage trucks that traverse the community. Figure 7, shows the Working face of dimension rock quarry in Consolidated Contractors Company (CCC) Quarry Limited, Iyuku. The massive blast with high proportion of boulders is an indication of excessive use of explosive or uncontrolled blasting, causing geo-hazards.

**Figure 6:** An abandoned quarry pit situated within the sampling sites.

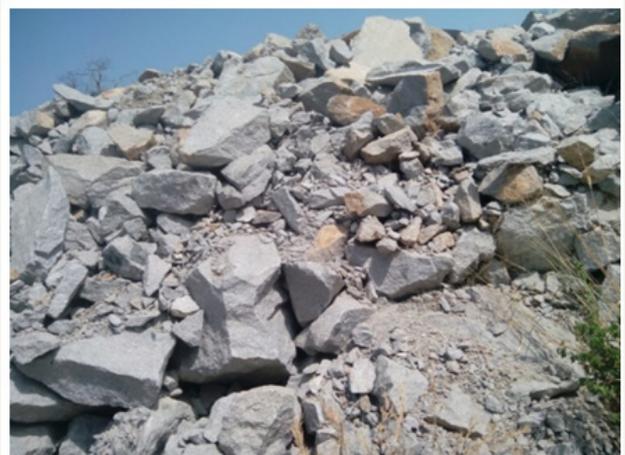
**Figure 7:** Blasted rocks at consolidated contractor's company.

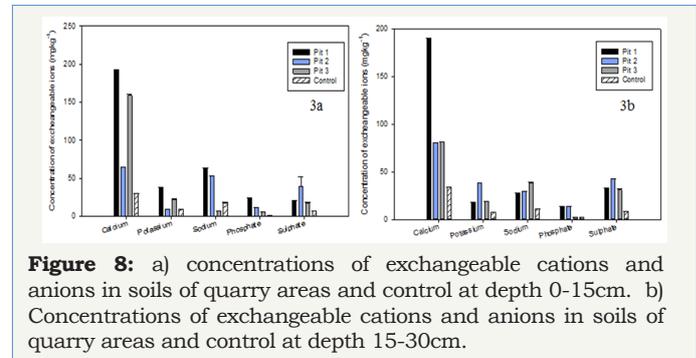
**Figure 8:** a) concentrations of exchangeable cations and anions in soils of quarry areas and control at depth 0-15cm. b) Concentrations of exchangeable cations and anions in soils of quarry areas and control at depth 15-30cm.

The exchangeable cations analyzed in this study were Calcium, Potassium and Sodium in mg/kg. These cations, at each pits and depth were significantly different from the control pit ( $P < 0.05$ ) except potassium at pit 2 which was not different from control at the surface soil (0-15cm),  $F(7, 23) = 1174.21$ ,  $P = 0.204$ . See Table 1. The exchangeable cations vary across pits at both surface and subsurface soil. The highest value of calcium was recorded at pit 1 ( $192.22 \pm 0.10$  and  $189.75 \pm 0.57$ ) with the lowest at pit 2 within the surface soil ( $64.18 \pm 0.084$  mg/kg).

Potassium was high at surface soil of pit 1 ( $38.31 \pm 0.055$ ) while the lowest was recorded at pit 2 ( $9.29 \pm 0.057$  mg/kg). For sodium, the highest was also recorded at pit 1 within the surface soil

( $62.9 \pm 0.032$  mg/kg) while the lowest was recorded at pit 3 with value far lesser than control at depth of 0-15cm. See Figure 3a & 3b. Among the exchangeable cations, calcium was the highest while the lowest was potassium i.e.  $\text{Ca}^{2+} > \text{Na}^{+} > \text{K}^{+}$  (Table 1). Pit 1 was highest in phosphate ( $\text{PO}_4^{2-}$ ) while sulphate ( $\text{SO}_4^{2-}$ ) was highest in pit 2 compare to other pits and control with concentrations of  $24.07 \pm 0.03$  mg/kg and  $42.78 \pm 0.31$  mg/kg respectively (Figure 8a & 8b).

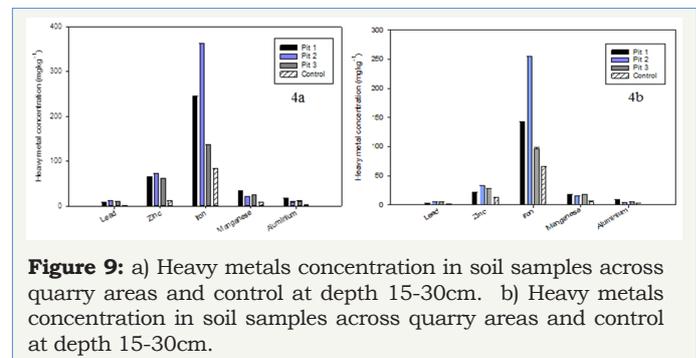
**Figure 9:** a) Heavy metals concentration in soil samples across quarry areas and control at depth 15-30cm. b) Heavy metals concentration in soil samples across quarry areas and control at depth 15-30cm.

Levels of Fe, Zn, Mn, Al, and Pb in mg/kg respectively were 95.97-245.85, 21.28-72.11, 14.85-33.12, 3.91-16.85 and 3.20-8.69 in all the soil samples from the quarry areas. Also, the levels of Fe, Zn, Mn, Al, and Pb in mg/kg respectively were 65.81-83.85, 12.34-12.39, 4.96-8.18, 2.89-3.10 and 0.37-1.24 in the background (control point). Fe was the highest detected in soils from both quarry areas and background (control). The order of concentration was found as  $\text{Fe}^{2+} > \text{Zn}^{2+} > \text{Mn}^{2+} > \text{Al}^{3+} > \text{Pb}^{2+}$  (Figure 9a & 9b).

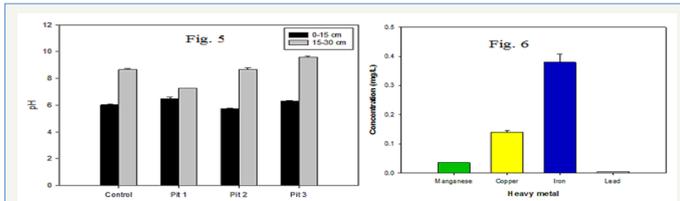
**Figure 10:** pH concentration of soil samples across quarry areas and control.

Pit 2 has the highest concentration of iron at both surface and subsurface soil i.e. ( $362.21 \pm 0.017$  mg/kg) and ( $254.92 \pm 0.16$  mg/kg) when compared to control ( $83.85 \pm 0.12$  mg/kg) and ( $65.81 \pm 0.68$  mg/kg) at each depth respectively. Concentration of Zinc was also highest in pit 2 ( $72.11 \pm 0.015$  mg/kg) with the least recorded in control pit at both depths (Figure 9a & 9b). For manganese and aluminum, the highest was recorded in pit 1 at the surface soil with the least observed in control pit. The highest concentration of lead was recorded in pit 2 at surface soil i.e.  $11.74 \pm 0.14$  mg/kg compared to surface soil in control pit ( $0.37 \pm 0.019$  mg/kg). Hydrogen ion concentration (pH) across all the pits varies with depth, with the highest pH recorded in pit 3 ( $9.59 \pm 0.095$ ) at depth of 15-30cm (Figure 10).

The pH concentrations show that surface soils (0-15cm) across the quarry area is acidic which supports the precipitation and mobilization of heavy metals. Such acidic soils can reduce the ability of microbes to fix atmospheric nitrogen and retarding the breakdown of organic matter, thus rendering such land unsuitable for plant growth. pH of the pond read 7.2, which imply that the pond is slightly alkaline and maybe favorable to the existence of bacteria. The excess phosphate is a source of nutrients to plants and it's responsible for the heavy growth of plants on the water surface. Figure 6 shows the concentration of heavy metals in the abandoned pond. Iron concentration in the pond far exceeds allowable limits. The high concentration of Iron (Fe) in the water enhances the growth of iron dependent bacteria that affects the water taste, cause production of slimes and objectionable odor. VES investigation indicate occurrence of water at relatively shallow depths, in pockets of rock fractures confirming that heavy metals and toxins could easily infiltrate or leach through the soil profile to contaminate groundwater in Iyuku.

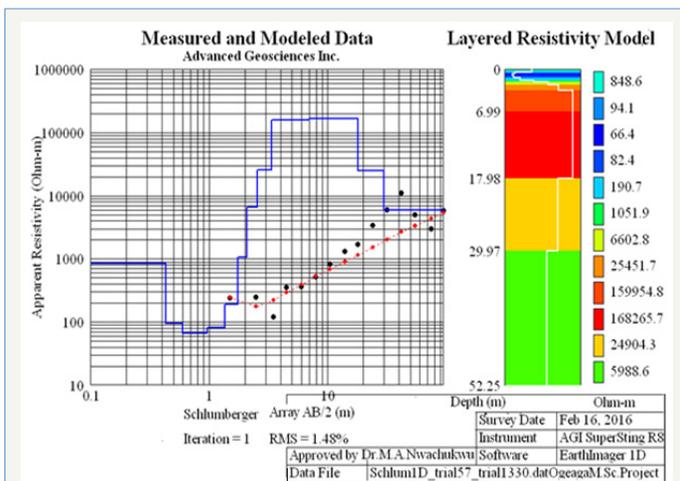
VES revealed twelve geo-electric layers (Figure 12) that was constrained to 5 as follows: Layer one was topsoil with depth (0.83m) and resistivity of 115ohm-m. Layers 2-4 were silty-sand, and fairly water saturated. Below this overburden was quartzite, followed by the target rock granite of high resistivity  $1.65 \Omega$ -m. Presence of quartzite could be described as contact metamorphism of sandstone due to high temperature of ejected volcanic magma. Although, the area has high elevation above mean sea level, groundwater occurs at very shallow depth below topsoil and in pockets of fractures.

**Figure 12:** Vertical electrical sounding across the pits within the quarry site.
