## Retreatment in Endodontics: A Case Report

Case of failed root canal treatment associated with a previous inadequate root canal treatment and faulty post placement. The patient reported with symptomatic apical periodontitis.

- A. Identification: Right mandibular first molar (Tooth 46).
- B. Dental history: Chief complaint: I am having pain when I eat or put pressure on my tooth. History of previously attempted root canal treatment done on right mandibular first molar. Root canal was done 2 years back.
- C. Clinical examination findings: The tooth 46 is tender to percussion and had a resin composite restoration and occlusally the metallic post was visible.
- D. Preoperative radiological assessment: The periapical radiograph revealed previous root canal treatment in 46. The tooth 46 and had a metallic screw/threaded post in distal canal (Figure 1).

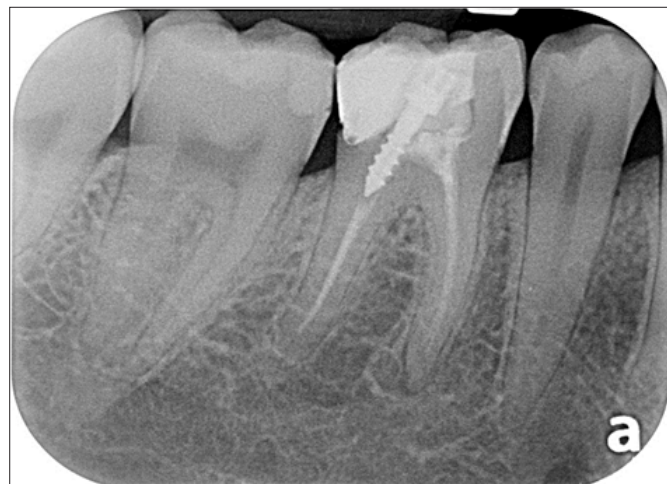
**Figure 1:** Periapical radiograph inadequate root canal treatment in 46. Periapical radiolucency associated with the mesial roots can be seen. Metallic threaded post can be seen in the distal canal.

E. Diagnosis (pulpal and periapical): Symptomatic apical periodontitis with inadequate root canal treatment.

The patient was informed about the problem and advised retreatment in 46. Patient advised about post removal to be done, presence of cracks to be explored and retreatment to be done along with location of missed canals will be attempted.

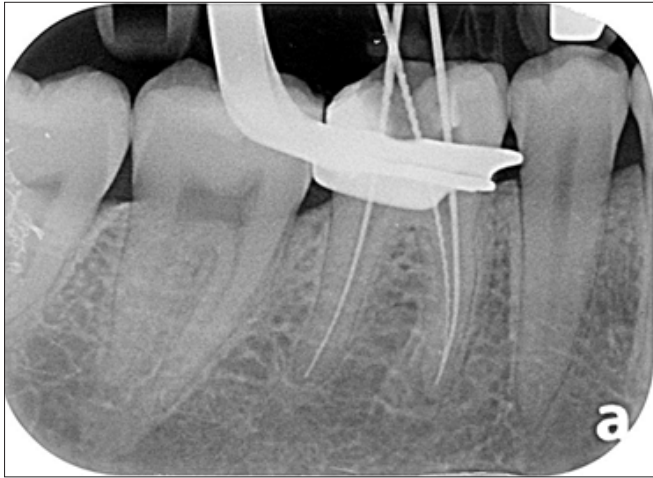
**Figure 7:** Periapical radiograph showing working length determination after gutta percha removal.

In addition to the removal of gutta perchas, final cleaning and shaping of the canal was planned in this visit. If the patient remained comfortable throughout the appointment and if time permits obturation was also planned in the same appointment. Once the removal of gutta perchas were done. Access cavity was explored for presence of cracks and extra canals. No extra canals were found. Endodontic hand files were used to determine working length along with electronic apex locator. The working length was verified with periapical radiograph (Figure 7). The canals were finally cleaned and shaped with Hyflex CM files up to size 25/04.

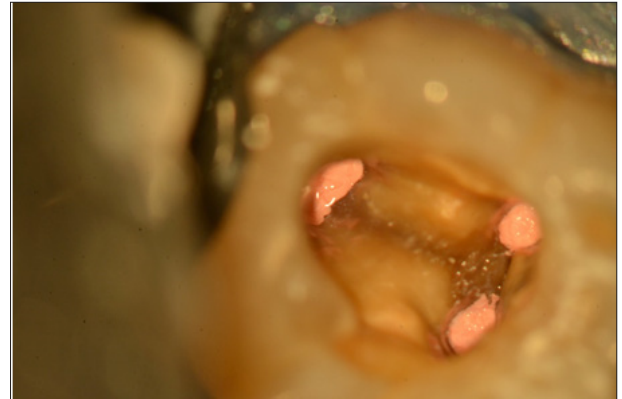
**Figure 10:** Immediate clinical picture showing obturation of all the canals up to the canal orifice.

Total fill, a bioceramic sealer from FKG was used along with gutta-percha as the core obturating material. The premixed sealer was applied in the canals with the help of disposable dispensing tips. The master cones were coated with the sealer and placed

inside the canals. The gutta percha was cut at the orifice level with heated Plugger. All the canals were obturated and the pulp chamber

cleaned of any gutta percha or sealer (Figure 10). Immediate postoperative radiograph was taken to verify the final obturation.

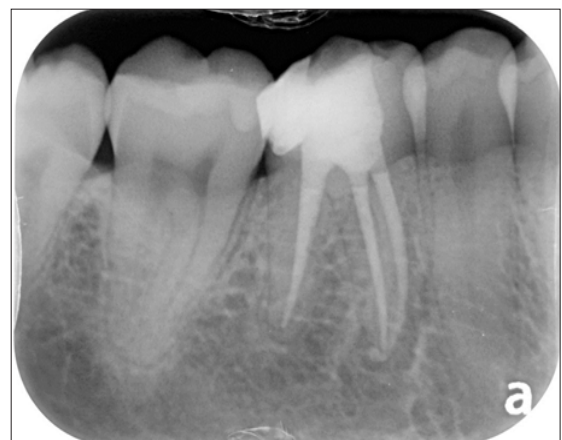
**Figure 11:** Immediate post-obturation periapical radiograph confirming the obturation of all the canals up to the calculated working length.

Proper cleaning and shaping of the root canals along with adequate disinfection is one of the important requirements for the success of the endodontic treatment. Failure to achieve adequate disinfection through irrigation will lead to left over microorganisms or pulpal debris leading to post-treatment infections (Figure 11).
