# Polyethylene Liner Dissociation with the Depuy Pinnacle Cup: A Report of 6 Cases

This case report discusses six cases of liner dissociation with the Pinnacle acetabulum following primary total hip arthroplasty. Cases involved a 54mm, 55mm, 56mm or 58mm Pinnacle cup with a neutral polyethylene liner and a 28mm femoral head with either an uncemented Corail or cemented C-Stem femoral prosthesis. Liner dissociation occurred between six months and 19 months post-operatively and all cases occurred following hip flexion. Revision involved replacement of the dissociated liners with either a neutral or lipped liner (Pinnacle or Ultamet polyethylene or metal) and in four of the six cases the femoral head size was increased. In all six cases the dissociated liners were found to have three of the six peripheral locking tabs sheared off. We explore possible causes for liner dissociation.

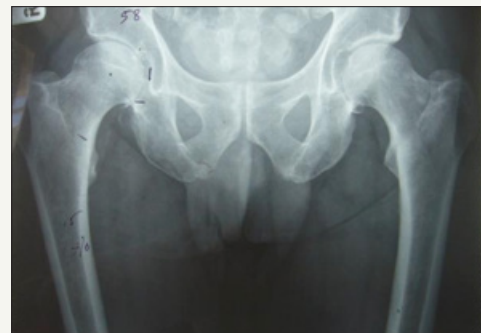
Figure 1: AP Pelvis showing right hip osteoarthritis.

A 64 year old male underwent right total hip arthroplasty for osteoarthritis (Figure 1). A 58mm Pinnacle sector 2 acetabular cup with a neutral Marathon polyethylene liner (28mm ID x 58mm OD)

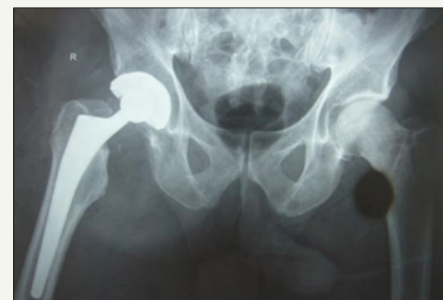
Figure 2: Post-op right total hip arthroplasty.

was mated via a 28mm+5 high offset stainless steel Articul/Eze femoral head (12/14 cone) to an uncemented No 14 Corail stem. Post-op recovery was uneventful. Post-op X-Rays showed 37° of inclination of the cup (Figure 2).

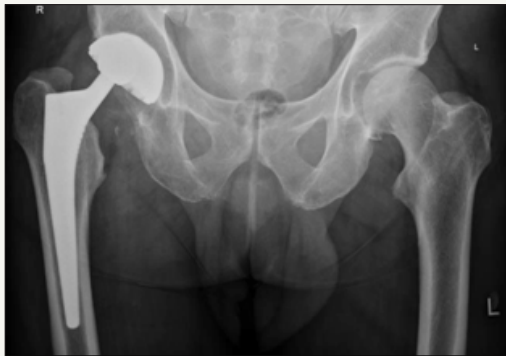
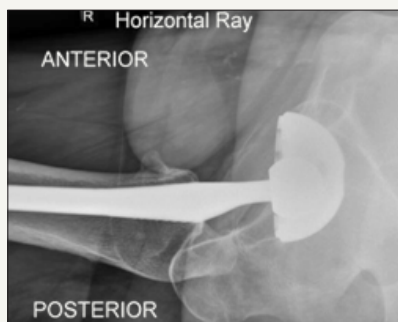
At six week follow-up he did report one episode of instability a week prior when getting up from a chair and he felt a sudden “pop” in his hip with flexion but otherwise continued to mobilise independently. At 14 months post-op he presented acutely after bending forwards, again flexing at his hip, and feeling something “pop” in this hip. He was unable to mobilise. On further questioning he reported multiple episodes of instability during the past year. X-Rays showed an eccentrically placed femoral head with no evidence of femoral or acetabular loosening or shift (Figure 3 & 4).

**Figure 3:** AP film showing disassociation.

**Figure 4:** Liner disassociation on lateral (horizontal ray) film.

He underwent revision where it was found that the superior three of the six peripheral locking tabs had sheared off from the liner resulting in the liner disassociating inferiorly and anteriorly leaving the superior aspect of the cup exposed to the metal head. Cup and femoral anteversion were deemed acceptable and there

was no evidence of loosening. Both were therefore retained. The disassociated liner was replaced with a neutral metal Pinnacle liner (40mm ID x 58mm OD) and the femoral head component with a 40mm +1.5 offset stainless steel Articul/Eze head (12/14 taper). Post-operative recovery was uneventful. At six weeks and one year post-operatively he reported no further instability (Figure 5).

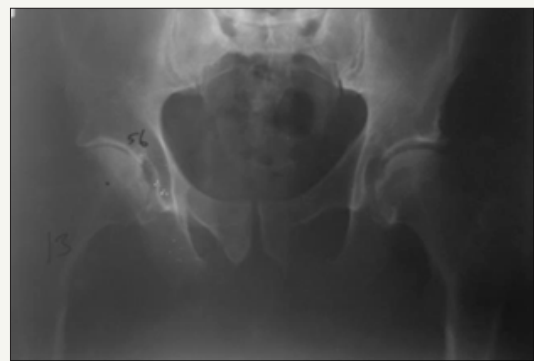
**Figure 6:** Pre-op AP film showing right hip osteoarthritis.

A 70 year old male underwent right total hip arthroplasty for osteoarthritis (Figure 6). A 56mm Pinnacle sector 2 acetabular cup was inserted with a neutral Marathon polyethylene liner (28mm ID x 56mm OD) and mated via a 28mm+5 high offset stainless steel Articul/Eze femoral head (12/14 cone) to an uncemented No 11 Corail stem. Post-op recovery was uneventful. Post-op X-Rays showed 46° of inclination of the cup (Figure 7).

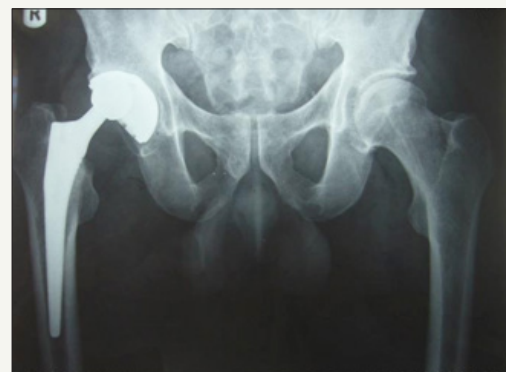
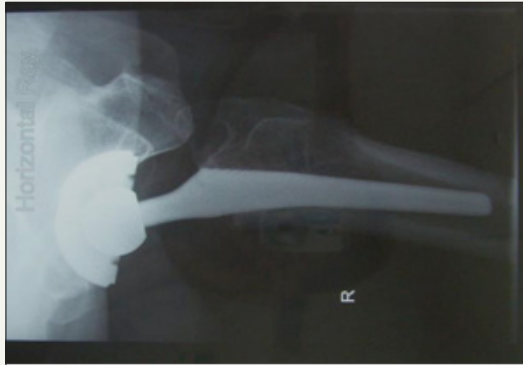
**Figure 8:** Right hip liner disassociation.

At six week follow-up he was noted to have a slight Trendelenburg gait but was otherwise well with no reports of instability. At 19 months post-op he presented acutely after bending forwards flexing at his hip and feeling something “pop” within his hip. He was able to mobilise soon after although with some difficulty and reported feeling something “rubbing” within the hip. Again, X-Rays showed an eccentrically placed femoral head (Figure 8 & 9).

**Figure 9:** Lateral film showing liner disassociation.

He underwent revision surgery where again it was found that the three consecutive superiorly placed locking tabs had sheared off resulting in the liner dissociating. Again cup and femoral anteversion were deemed acceptable and there was no evidence of loosening and both were therefore retained. The disassociated liner was replaced with a neutral metal Pinnacle liner (36mm IDx56mm OD) and the femoral head component with a 36mm +5 offset stainless steel Articul/Eze head (12/14 taper). Post-operative recovery was uneventful and on review in outpatient clinic 6 weeks post-op and at one year he was mobilising well with full range of movement of the hip and reported no further episodes of instability (Figure 10).

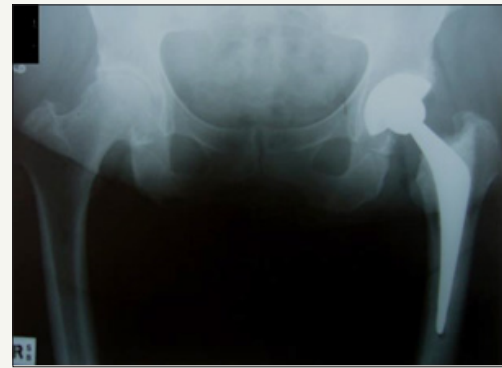
**Figure 11:** Pre-op film showing right hip osteoarthritis.

A 67 year old female underwent right total hip arthroplasty for osteoarthritis (Figure 11). A 56mm Pinnacle sector 2 acetabular cup with a neutral Marathon polyethylene liner (28mm IDx56mm OD) was mated via a 28mm+3 stainless steel Elite femoral head (9/10 taper) to a cemented No 2 high offset C-Stem (9/10 taper)

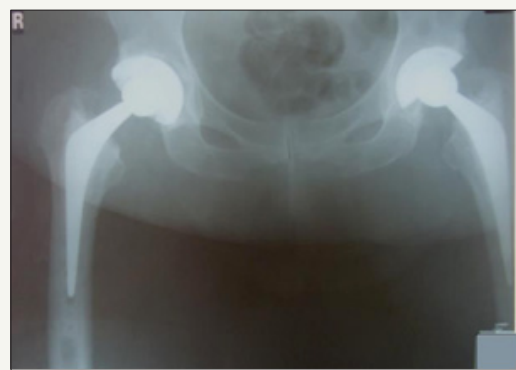
**Figure 12:** Post-op film showing right total hip arthroplasty.

femoral component. Post-op recovery was uneventful and X-Rays showed 46° inclination of the cup (Figure 12).

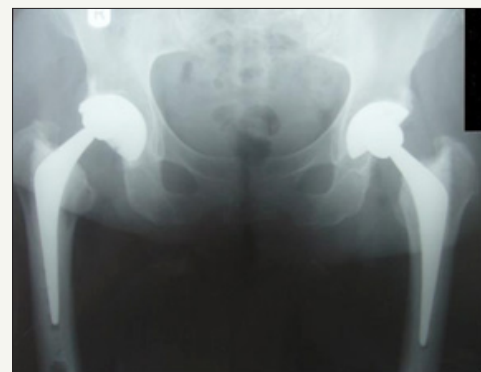
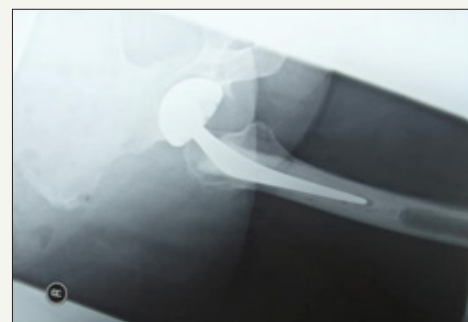
**Figure 13:** Right hip disassociation.

**Figure 14:** Lateral film of disassociation.

At six week follow-up she was mobilising well, with good range of movement of the hip and no complaints of pain. At six months post-op she was seen acutely after feeling a pop in her hip following flexing forwards. She complained of pain in her groin and was noted to be walking with a limp. X-Rays showed an eccentrically placed femoral head (Figure 13 & 14).

She proceeded for revision. Again the three superiorly placed locking tabs of the six had sheared off resulting in the liner lying loose. Cup and femoral anteversion were deemed acceptable and there was no evidence of loosening. The disassociated liner was replaced with a neutral metal Pinnacle liner (36mm IDx56mm OD) and the femoral head component with a 36mm+3 offset stainless steel Ultamet femoral head (9/10 cone). Post-op recovery was uneventful and on review in outpatient clinic both at six weeks and two years post-op she remained well with full range of movement of the hip and no further instability (Figure 15).

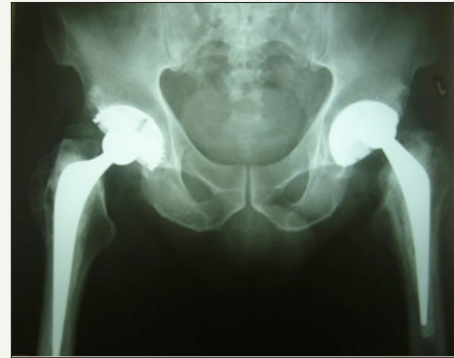
**Figure 18:** AP Pelvis showing eccentrically positioned femoral head within the Pinnacle acetabulum.

At six week follow-up he was mobilising well with good range of movement of the hip. At seven months post-op he saw his GP complaining of a clunking sensation in his hip and his hip feeling unstable. X-Rays were taken which showed no abnormalities. However, at 10 months post-op he was seen acutely after flexing forwards and feeling his hip "pop". X-Rays showed an eccentrically placed femoral head. Lateral films were not available (Figure 18).

He proceeded for revision where it was found that the three antirotation superior locking tabs had sheared off resulting in the liner lying loose inferiorly and anteriorly. Cup and femoral anteversion were deemed acceptable and there was no evidence of loosening. The disassociated liner was replaced with a neutral Ultamet metal liner (36mm IDx56mm OD) and the femoral head component with a 36mm+3 offset stainless steel Ultamet femoral head (9/10 cone). Post-op recovery was uneventful and on review in outpatient clinic at six weeks, nine months and two years he remained well with full range of movement of the hip (Figure 19).

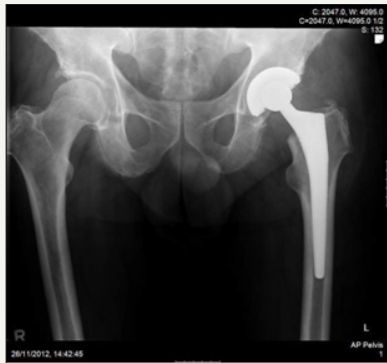
**Figure 20:** Post-op left total hip arthroplasty.

Marathon polyethylene liner (28mm IDx56mm OD) implanted with a 28mm+1.5 stainless steel Articul/Eze femoral head (12/14 taper) and uncemented No 13 high offset Corrail femoral component. Post-op X-Rays showed 40° of inclination of the cup (Figure 20). At exactly one year he presented acutely with pain in his left hip after twisting and flexing at his hip to pick up his dog. X-Rays showed an eccentrically located femoral head (Figure 21 & 22).

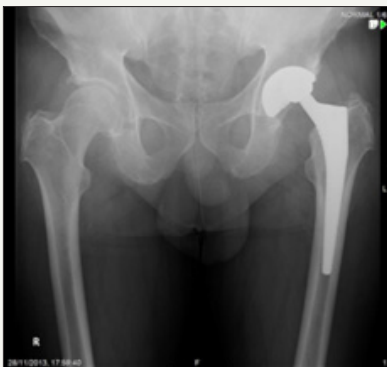
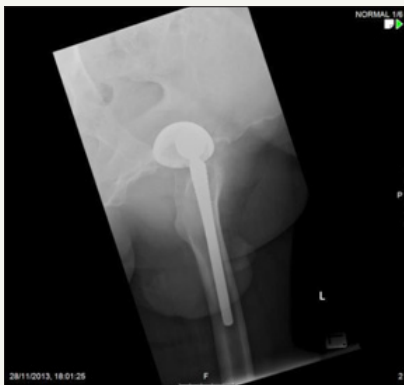
**Figure 21:** Dissociated liner (AP radiograph).

**Figure 22:** Dissociated liner (lateral radiograph).

He underwent revision where it was found that the 3 superior locking tabs had sheared off and the liner had spun out. The liner and head were replaced with identical sized components. At 6 weeks and one year post-op he was mobilising well and without pain and denied any further instability (Figure 23).

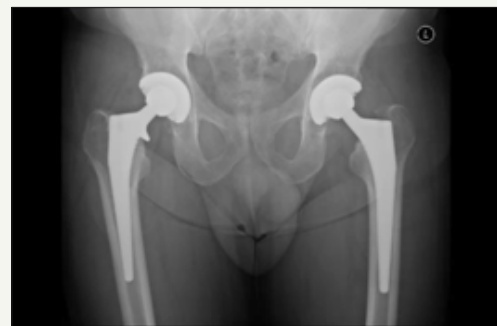
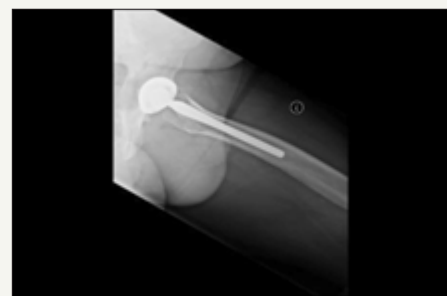
A 58 year old male underwent left total hip arthroplasty for osteoarthritis. Implants used were a 54mm Pinnacle Duofix HA 100 series acetabular cup with a neutral Marathon polyethylene liner (28mm IDx54mm OD) implanted with a 28mm+1.5 Biolex Delta ceramic femoral head (12/14 taper) and uncemented No 12 lateral offset Corrail femoral component. Post-op course was uneventful with X-Rays showing 42° of cup inclination (Figure 24 & 25).

**Figure 24:** Post-op left total hip arthroplasty.

**Figure 25:** Post-op left total hip arthroplasty (lateral radiograph).

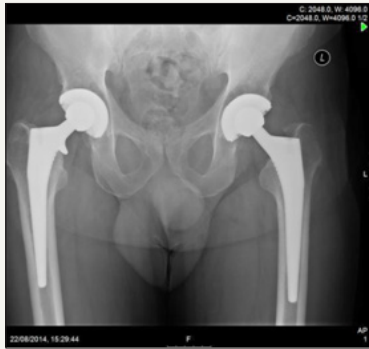
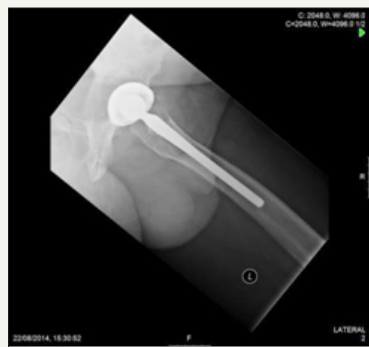
this case the 3 were not adjacent lugs). The head was exchanged and a lipped polyethylene liner was placed. At 9 months post-op he continues to do well (Figure 26-29).

**Figure 26:** Post-revision left hip arthroplasty.

**Figure 27:** Post-revision left hip arthroplasty (lateral radiograph).

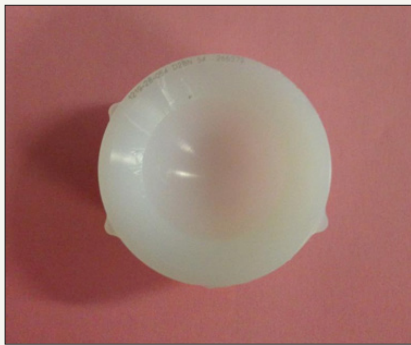
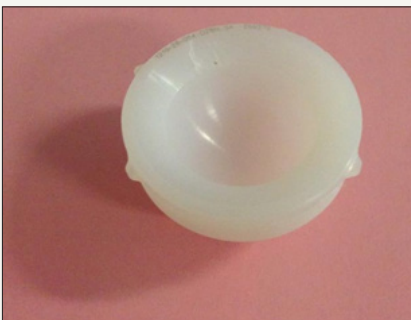
Four months later he was reviewed and reported four or five episodes of subluxation of the hip (whilst in the shower and when bending forwards to pick up socks). A month later he had a more severe episode in which the pain did not resolve and X-Rays showed an eccentrically positioned femoral head. He underwent revision where three of the six anti-rotation lugs were broken (although in

**Figure 28:** Dissociated Pinnacle polyethylene liner showing three of the six locking tabs have sheared off.

**Figure 29:** Only three of the six derotation locking tabs remain.

In all four cases it was the superior three of the six peripheral locking tabs that were found to have sheared off. Whether these three tabs play more of a stabilising role than the inferiorly placed tabs or whether being positioned superiorly places the tabs under more stress thus making them more prone to fracturing is also something to ponder.
