# Intra-Pelvic Cup Migration as an immediate Post-Operative Complication

Intra-pelvic cup migration is a rare but severe complication, mainly, due to the potential damage of vascular and other pelvic structures. This complication can result from several situations as aseptic loosening, dislocation, acetabular fracture and implant related failure. Safe intra-pelvic material removal has to be prepared to diminish the potential risk of damaging intra-pelvic structures.

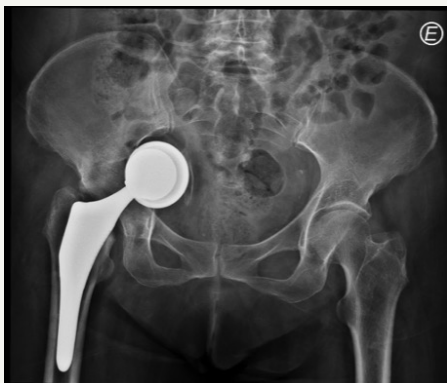
A 77-year-old female patient referred to our hospital due to an early postoperative complication: the intra-pelvic acetabular cup migration after primary hip arthroplasty. The patient had no relevant medical history. The x-rays showed intrapelvic protusio of the prosthetic cup (Figure 1).

**Figure 1:** AP X- ray view.

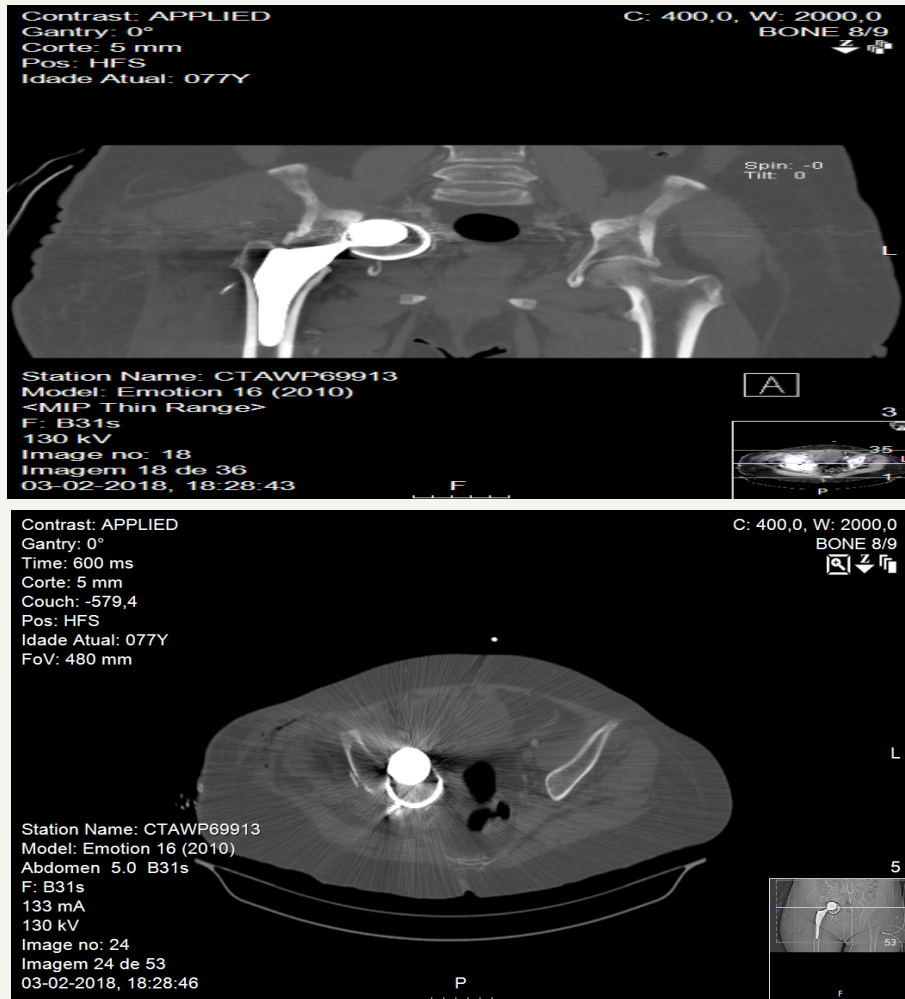
The CT scan showed a bone defect and the proximity of prosthetic implants to the iliac vessels. There were no clinical or laboratorial signs of infection (Figure 2).

**Figure 2:** CT Scan views showing the intrapelvic prosthetic migration.

The surgical procedure was done in two stages. The first in supine position: the Stoppa approach with the removal of the acetabular cup [1]. The second in lateral decubitus position: the Hardinge approach with the revision of the acetabular cup with a Bush-Schneider ring with a polyethylene cementation. As the

The migrated acetabular cup can remain inaccessible through the conventional approach to the hip joint and the removal of the hardware can be difficult and dangerous [4]. The Stoppa approach, a retroperitoneal approach, offers a direct view of the prosthetic material allowing a safer withdrawal. The Stoppa approach is often used to repair acetabular fractures and as shown in this case can

also be used in failed hip arthroplasty with intra-pelvic socket migration. This approach has some advantages: it allows the removal of the migrated cup with very good control of intrapelvic structures and it is less invasive than the transperitoneal approach.

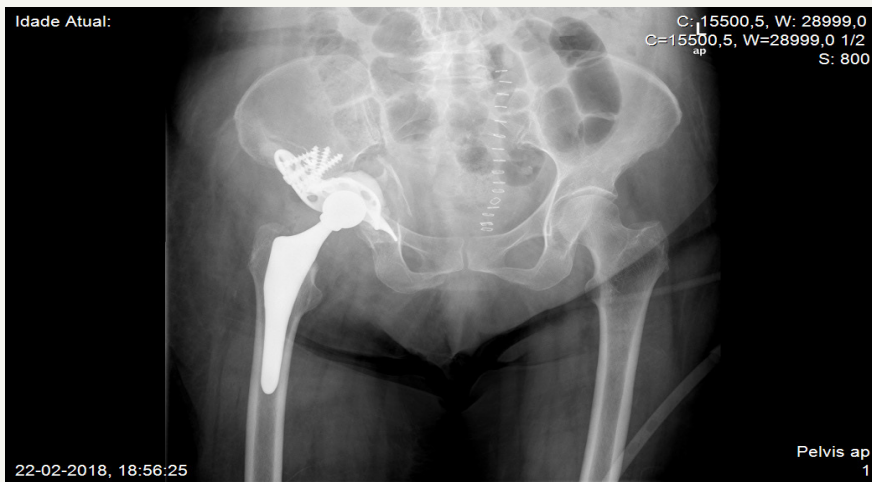
femoral stem did not show signs of loosening, it was left in place and only the femoral head was changed. The intra operative maneuvers for assessing stability and abductor tension were correct. The post operative x-ray showed no signs of failure. One week post-operatively the patient started weight bearing with progressive gait training (Figure 3); [2].

**Figure 3:** Postoperative X-ray.
