# Intra-Pelvic Cup Migration as an immediate Post-Operative Complication

Hospital Santa Maria, CHLN, Portugal

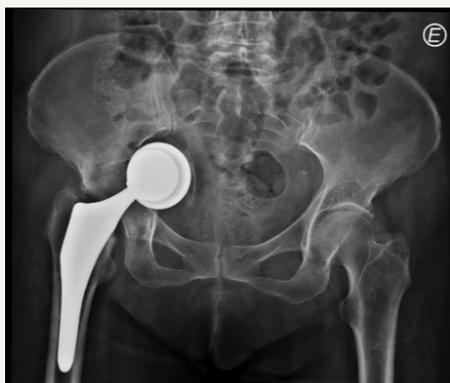
A 77-year-old female patient referred to our hospital due to an early postoperative complication: the intra-pelvic acetabular cup migration after primary hip arthroplasty. The patient had no relevant medical history. The x-rays showed intrapelvic protusio of the prosthetic cup (Figure 1).

**Figure 1:** AP X- ray view.

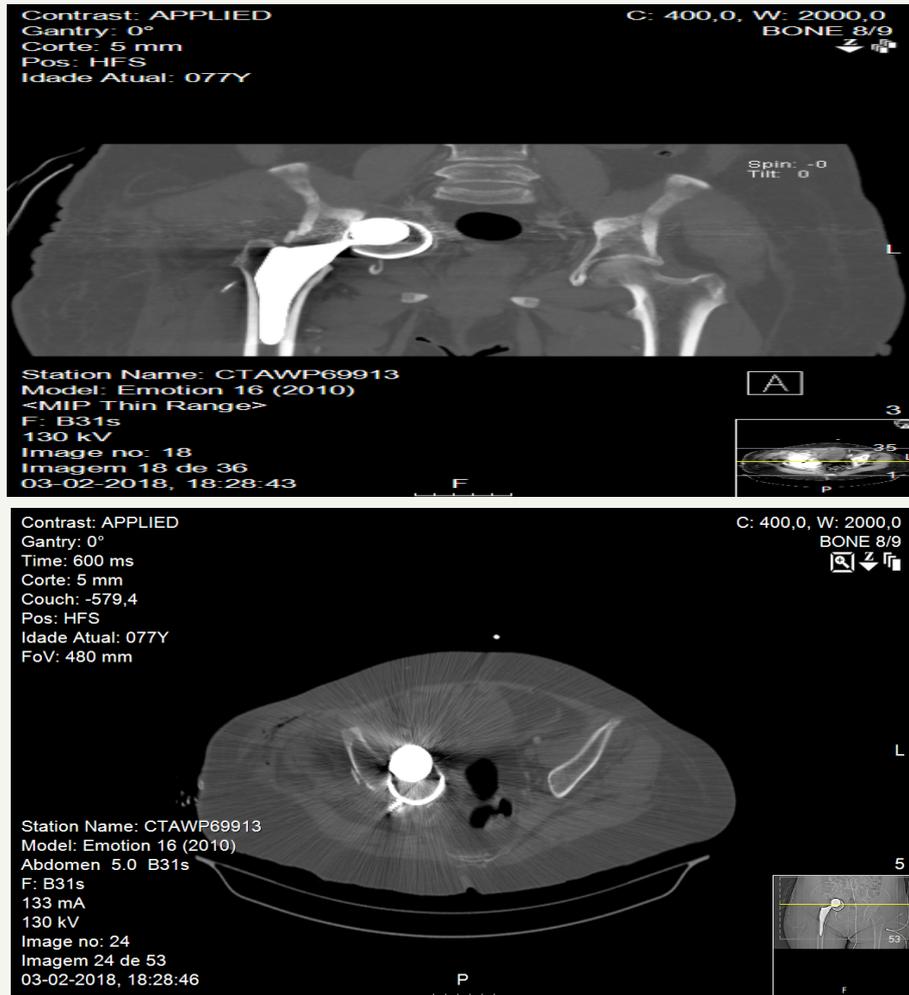
The CT scan showed a bone defect and the proximity of prosthetic implants to the iliac vessels. There were no clinical or laboratorial signs of infection (Figure 2).

Figure 2: CT Scan views showing the intrapelvic prosthetic migration.

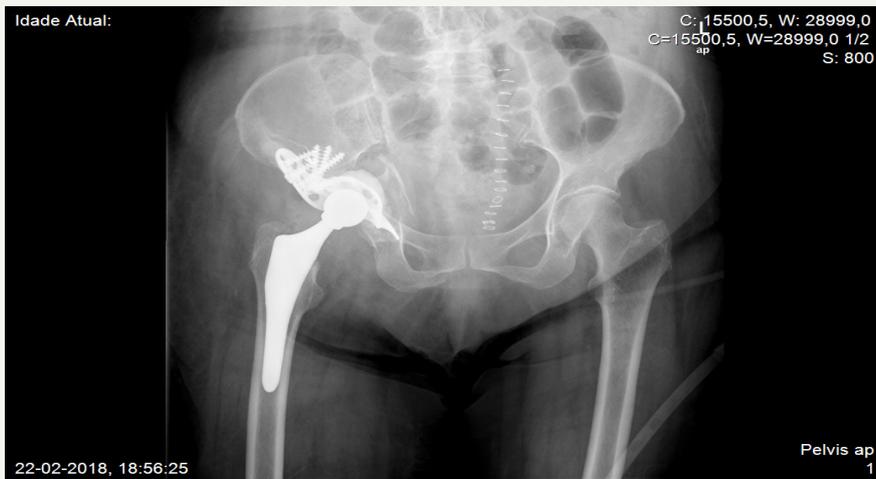
Figure 3: Postoperative X-ray.

The surgical procedure was done in two stages. The first in supine position: the Stoppa approach with the removal of the acetabular cup [1]. The second in lateral decubitus position: the Hardinge approach with the revision of the acetabular cup with a Bush-Schneider ring with a polyethylene cementation. As the

femoral stem did not show signs of loosening, it was left in place and only the femoral head was changed. The intra operative maneuvers for assessing stability and abductor tension were correct. The post operative x-ray showed no signs of failure. One week post-operatively the patient started weight bearing with progressive gait training (Figure 3); [2].
