Frost Action Damages Effect in Correlation with IRI Data: A Study on Sections of Road BD97 and BD841

Ludvig Danfors¹, Niklas Mannelqvist¹, Tarun Bansal^{1*} and Virgilio Pérez²

¹Luleå University of Technology, Sweden

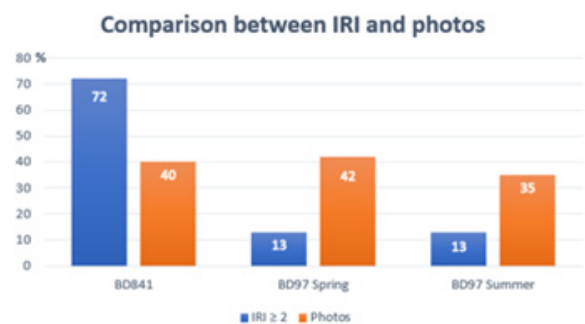
Figure 8: Comparison between IRI and photos.

In Figure 8, a comparison between IRI data and photos is presented. However, the photos show how much of the studied road
