Characterization of the Damage Mechanism of Composites against Low Velocity Ballistic Impact Using Computed Tomography (CT) Techniques

Emre Yılmaz, Mehmet Gökhan Gökçen, Alparslan Demirural and Tarık Baykara*

Department of Mechanical Engineering, Turkey

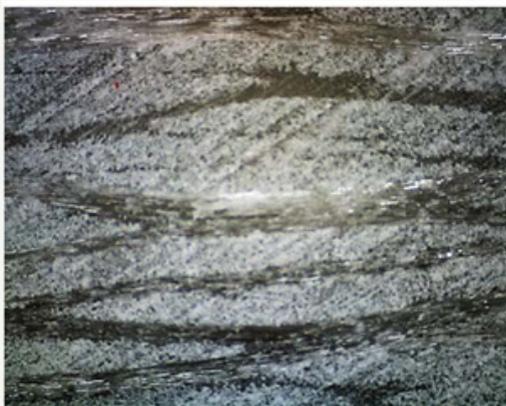
Figure 1: Cross sectional micrograph of the laminated composite. Blackish bands show the parallel fiber layer (in 0°) and the remaining lighter areas show the fiber layers in transverse direction (in 90°).

to manufacture panels with dimensions 40x40x11mm. Panels were then compressed under a 60 tons hydraulic press for 30 minutes applying approximately 100 bar pressure. Pressed panels were then post-cured in an oven at 85 °C for 2hrs. Cross sectional view of the laminated composite indicates a pore and void free structure as shown in Figure 1.

Following a carefully designed processing route to produce composite panels, a void and pore free microstructure is obtained and illustrated in Figure 1. Panels were shot by a 9mm hand gun in an accredited polygon. Two samples extracted from these laminated, pressed and fully cured composite panels (cut from both x- and y-directions) were used in 3-point bending test and the resultant flexural stress vs. extension diagrams are shown below in Figure 5. The maximum flexural stresses were found to be 254.1MPa and 191.9MPa. Maximum flexural strains were found to be 0.060 and 0.021mm/mm respectively.

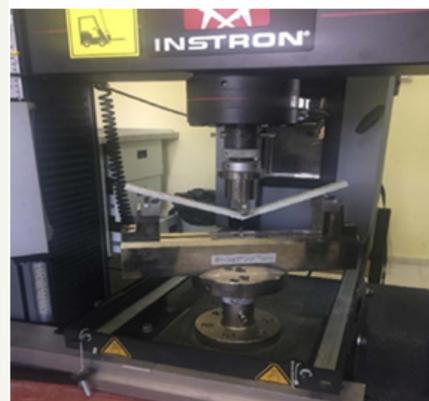
Figure 3: 3-Point Bending test for the composite specimen.

Following the ballistic shots, 3-Point bending test was carried out using 40x10 x11mm test pieces (cut from both x- and y-directions) by Instron 5982 Static Push Pull Instrument (Figure 3).

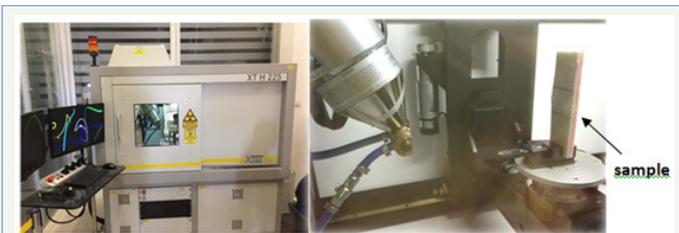
Figure 4: The NIKON XT H 225 CT system and the damaged sample.

Detailed damage mechanism of the impacted projectile was investigated using computed tomography (CT) techniques. Computed tomography devices are the most important which provide a better damage view for materials especially for the laminated composite structures. A computed tomography (CT) device has a stationary frame and a rotor, carrying an X-ray source and a radiation detector, which is rotatably mounted at the frame. A number of marks are provided at the rotor at known angular intervals, these marks being scanned by a sensor, which is attached at the frame and which emits an output signal given the passing of a mark. The number of marks is significantly lower than the number of projections that are picked up in each rotation of the rotor. A computing unit determines the projection angles pertaining to the individual projections by interpolation from the output signals of the sensor. As the CT instrument, the NIKON XT H 225 system was used to evaluate the penetration and damage mechanisms of the composite and the penetrated projectile (Figure 4).

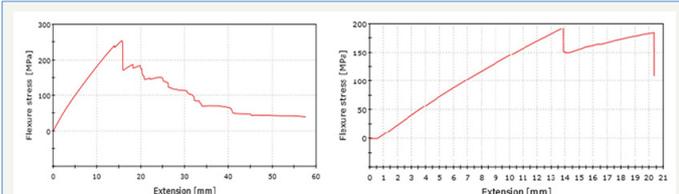
Figure 5: 3-Point bending test results for the composite samples.

The difference in both max flexural strength and max flexural strain is due to the difference in cutting directions of the samples

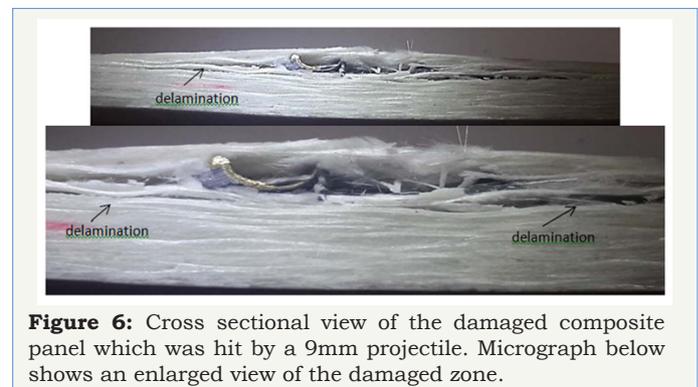
Figure 6: Cross sectional view of the damaged composite panel which was hit by a 9mm projectile. Micrograph below shows an enlarged view of the damaged zone.

Optical microscopy observation on the damaged zone reveals the damage mechanisms such as fiber breakage, matrix cracking and delamination along with the fragmented projectile pieces spreaded through the delaminated interfaces (Figure 6 & 7).

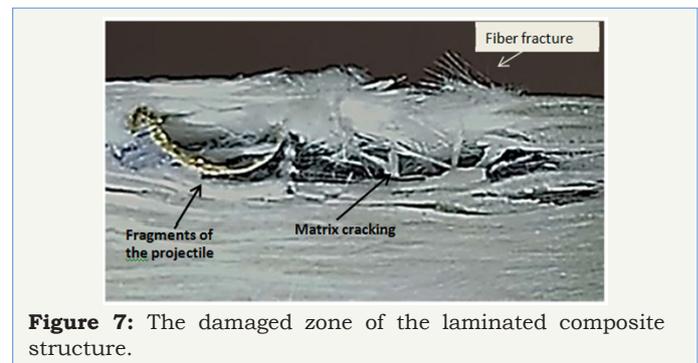
Figure 7: The damaged zone of the laminated composite structure.

Computed Tomography scans were applied to the same specimen for precise visualization of the damaged zone and the fragmented projectile (Figure 8-11). Figure 9 illustrates a general view of the CT scan of the damaged surface where a slight swelling on the surface can be seen. Accumulated bumps on the surface reveal those fractured fibers as also shown in Figure 7.

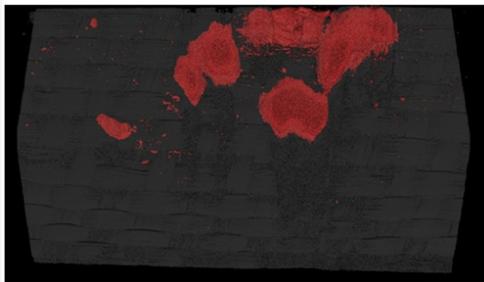
Figure 8: 3-D Transparency view of the fragmented projectile in the damaged zone.

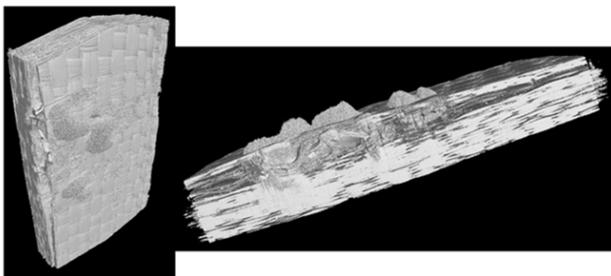
Figure 9: 3-D View of the computed tomography scan of the damaged zone

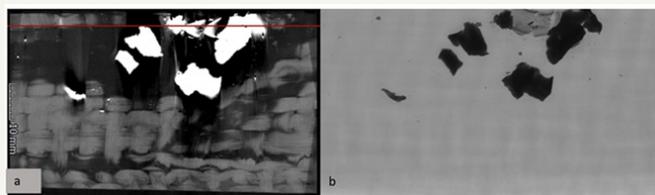
Figure 11a: CT scan of the damaged zone; 11b: Radiographic view of the fragmented projectile.

Figure 11a & 11b show the distribution of these copper-brass sheath fragments in the delaminated interfaces. Metallic pieces are spreaded in transverse direction and causing further propagation of the delamination process. At this point, it should be noted that computed tomography (CT) is such a powerful technique that it visualize the full extent of the damage progression in 3-D. It also reveals the distribution of the remnants of the fragmented bullet through the interfaces of the composite laminates.
