# Bacteria-Based Self-Healing Concrete: Towards Standardization

Mors RM<sup>1,2</sup> and Jonkers HM<sup>1\*</sup>

<sup>1</sup>Department of Materials, Mechanics, Management & Design (3MD), Netherlands

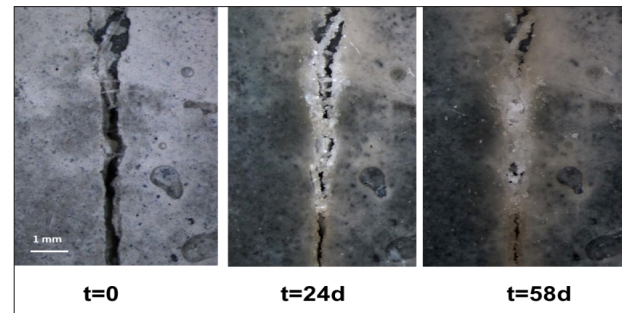
**Figure 2:** Self-healing of an 0.8-mm wide crack in concrete at a dosage of 15kg of self-healing agent per m<sup>3</sup> takes up to two months.

Limestone, or calcium carbonate, is a concrete compatible material that is perfectly suitable for sealing (waterproofing) cracks in concrete. Research has shown that lactate-based organic compounds are suitable nutrients for the bacteria and concrete compatible in the sense that they, within limits, do not negatively affect strength development of concrete, and as such lactate is also present in the declared list in the European norm on admixtures (EN 934 Admixtures for concrete, mortar and grout). Laboratory research has shown that, depending on the dosage of bacteria and lactate-based nutrients, cracks up to 1mm width can be sealed autonomously. This requires a dosage of 15kg of self-healing agent per m<sup>3</sup> of concrete mix, while a dosage of 5kg/m<sup>3</sup> leads to the autonomous waterproofing of 0.4mm wide cracks (Figure 2).

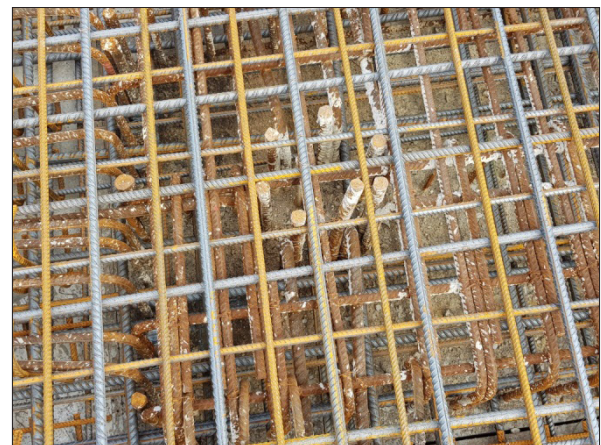
**Figure 3:** Picture of a finely meshed reinforcement network for watertight concrete constructions.

Constructions in wet environments can specifically benefit from self-healing of cracks. Watertight constructions are commonly designed in such a way that only cracks of smaller than 0.1mm width are allowed to occur. Such designs however require a lot of crack limiting reinforcement in addition to structural reinforcement steel. However, disadvantage of applying abundant steel is threefold: expensive, featuring high CO<sub>2</sub> footprint, and finely meshed network hampers casting of the concrete mix. Instead, designing watertight constructions for marine- and freshwater applications, allowing crack widths of 0.2 and 0.4mm respectively, would save substantial amounts of crack width limiting steel. This will result not only in more economic- and lower CO<sub>2</sub> footprint structures but also in easier processability of the concrete mix. Latter will allow to work faster and will also lower the risk of forming gravel nests and hollow spaces in the structure. Water tightness of these structures will be delivered by autonomous crack-sealing of mixtures requiring a dosage of up to 5kg/m<sup>3</sup> healing agent (Figure 3).
