Study on the Causes and Remedies of Ball Formation in Looms due to Improper Sizing

Taposh Ranjan Sarker*, SM Tufazzal Haider, AM Riasat Alam, Salim Ahmed, Sanaullah Murad and Ebrahim Shaikh

¹Lecturer, Department of Textile Engineering, Northern University Bangladesh, Bangladesh

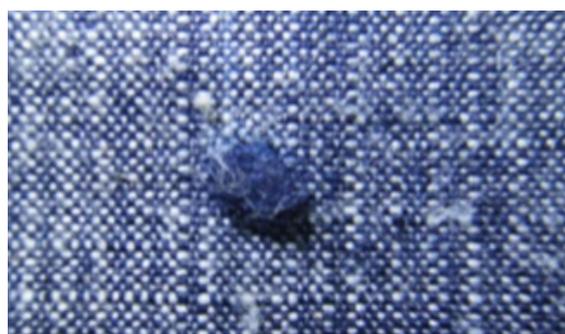
Figure 1: Ball formation.

weaving by becoming entangled in loom components and forcing them to “peel back” until a ball is formed, resulting in a break in the yarn and loom shutdowns [5]. If the yarn is not appropriately sized, it causes trouble and has a propensity to form balls [6] (Figure 1).

A ball, often known informally as a bobble or fuzz-ball, is a little ball of fibers that develops on a piece of fabric. It occurs when fabric processing causes slack fibers to protrude from the fabric’s surface, and abrasion induces the fibers to form into tiny spherical bundles held to the fabric’s surface by projecting fibers that haven’t broken [7] (Figure 2).

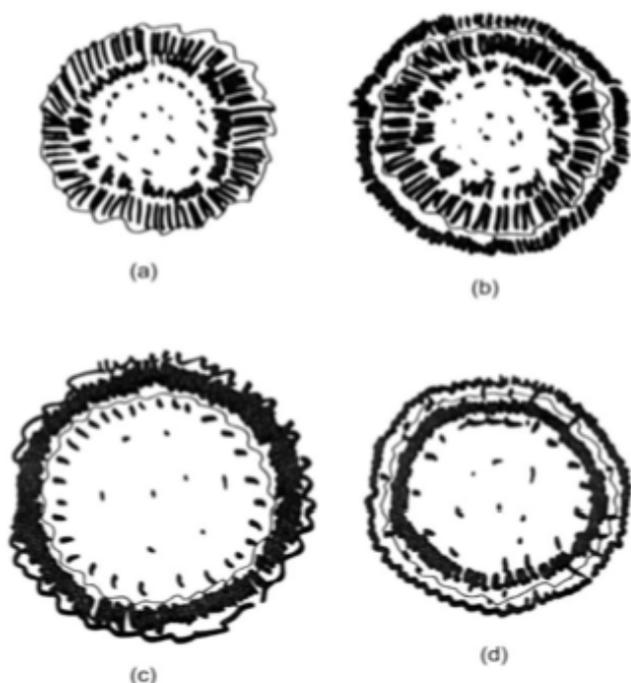
Figure 2: Schematic size distribution.

- Excessive penetration, no surface coating
- Too much penetration, extra size added to produce a surface covering
- Too little penetration, no yarn structure anchoring
- Optimal distribution.

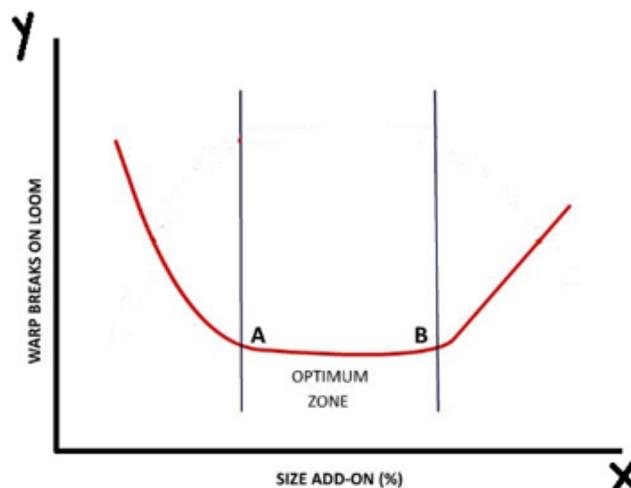
Figure 3: Sizing-weaving curve.

Appropriate changes in size ratios and shed geometry resulted in enhanced fiber lay and yarn surface qualities for increased productivity and quality without adding raw material costs on new high-speed shuttle-less weaving techniques [8]. The graph in Figure 3 is a common sizing-weaving curve [9].

Initially, the warp breaks lessen as the size add-on level increases. This is due to the increased yarn strength and decreased yarn hairiness [2]. The application of the protective size layer around the yarn improves abrasion resistance and offers appropriate protection to the yarn’s weak points [10]. With increasing size add-on, the reduction in warp breaking rate approaches a limit beyond which additional size add-on will not result in a meaningful improvement in yarn performance on the loom. When the warp breakage rate is at its lowest, weaving efficiency, which is inversely related to warp yarn end breakage rate, achieves its peak [11]. As seen in the typical curve in Figure 3, the appropriate range of size add-on is generally between points A and B. In fact, increasing the size add-on beyond the optimum has a negative effect on weaving performance because the warp breaks rise [6]. Excessive size add-on causes the size to penetrate further into the yarn, making it rigid. Furthermore, an increased size add-on may coat the yarn with a very thick layer of the size that is not suitably attached to the fibers [2]. When compared to the extensibility of the warp yarn, a thick coating of size film may have lesser extensibility. The inflexibility of the yarn and a loosely bonded size film result in size film shedding owing to facile rupturing, rendering the yarn prone to vigorous abrasion action and a greater warp breaking rate [10]. In reality, the best weaving efficiency area consistent with optimal size add-on is generally attained by trial and error [12]. Short fibers stick to the yarn surface and tend to cluster balls if sizing is not handled effectively [13].

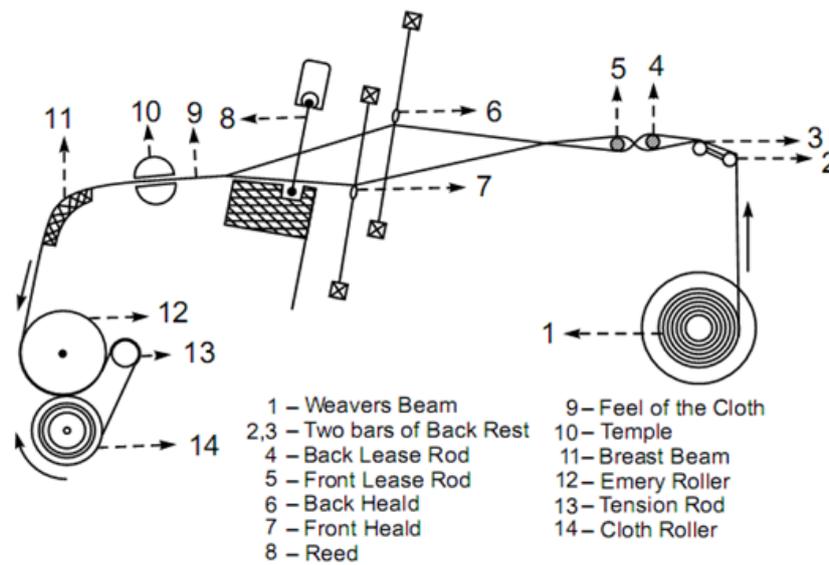
Figure 4: Important loom components and significant abrasion locations.

The approach used here is based on several loom settings. It was noticed how the loom settings decrease ball formation on yarn and cloth, and the best settings were computed (Figure 4).

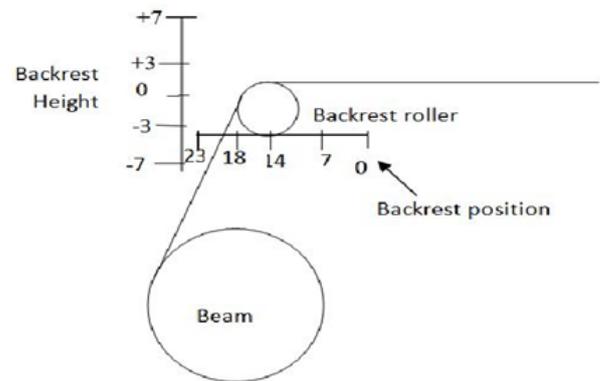
Figure 5: Adjustment of backrest position and height.

weaving operation was maintained. Identifying and managing the optimal warp tension increased weaving efficiency and fabric quality (Figure 5).

The Backrest roller is an important component of the weaving machine. Several looms were examined in order to determine the best backrest tension. The experiment was carried out using an identical set of backrest height, dropper location, and dropper height. The backrest roller was adjusted up and down while the backrest position, dropper position, and height remained unchanged. It was noticed that fabric quality is dependent on the backrest roller’s appropriate adjustment.

The distance between the dropper and the backrest roller is referred to as the dropper position. The dropper line connects the backrest or heald frame horizontally. Dropper depth is determined by the distance between the dropper line and the healed frame (Figure 5). All factors except the dropper position were held

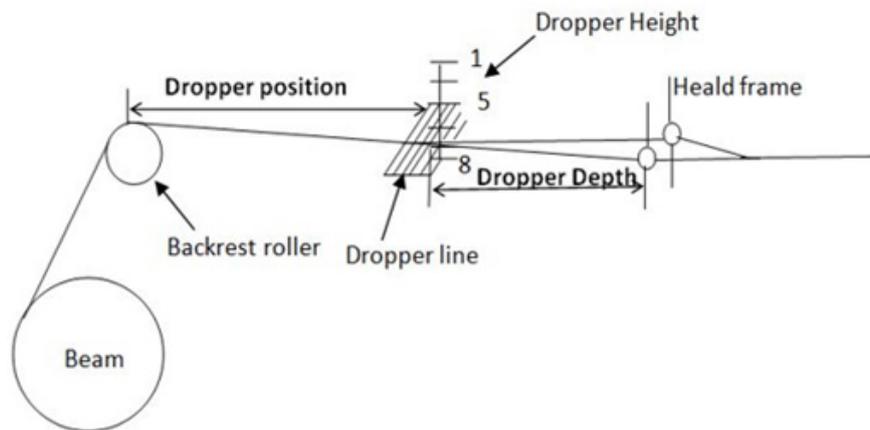
Figure 6: Adjustment of dropper position and height.

constant to evaluate the impact of changing the dropper location. It was learned that appropriate adjustment of this setting is beneficial

in eradicating the ball formation problem and improving fabric quality (Figure 6).

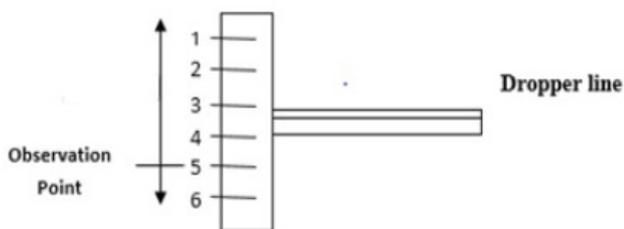
Figure 7: Changing the dropper height.

The dropper line can be shifted either up or down. The dropper height increases as the dropper line moves upward, and the backrest height decreases as the dropper line moves downward (Figure 7). However, it has been noticed that if the dropper line is situated closer to the heald frame, the influence of the dropper location negates the scenario.

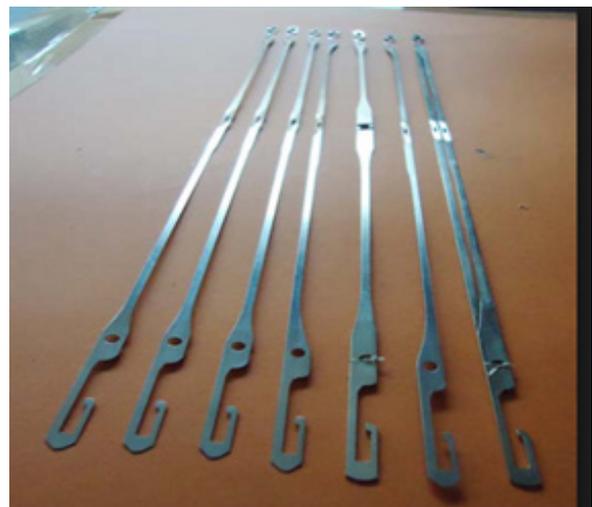
Figure 8: Simplex heald wire.

When comparing samples 1 and 2 of the same fabric structure and yarn count, it is clear that the amount of ball created has been reduced due to the use of duplex heald wire rather than simplex heald wire (Figure 8-11).

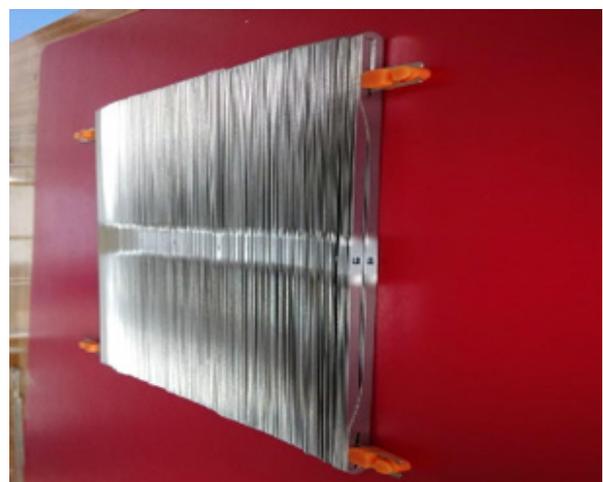
Figure 9: Duplex heald wire.

Since duplex two-healed wires have more space between them yarns can travel through them more easily and friction among neighboring yarns is minimized. As a result, the tendency to create balls is diminished.

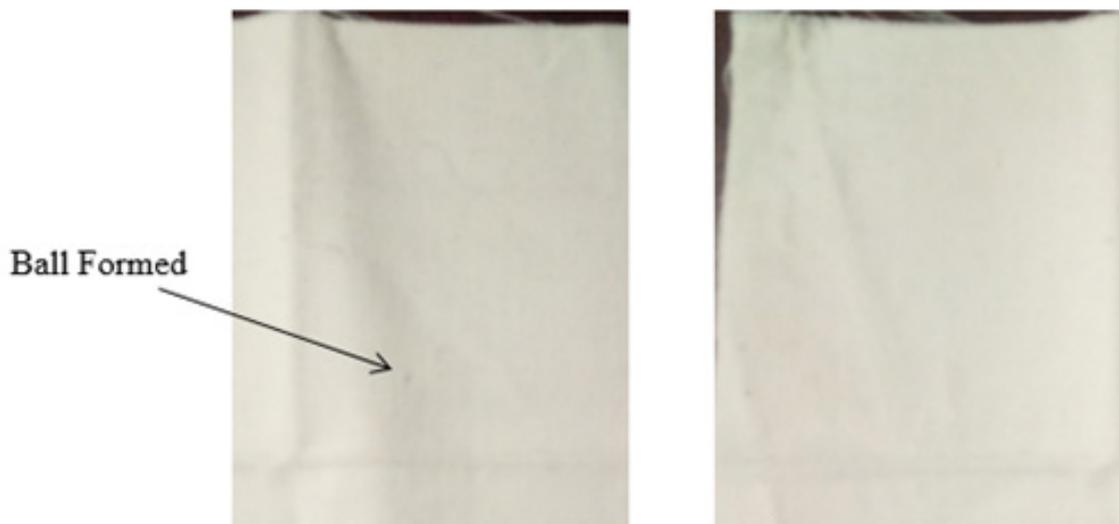
Figure 12: Ball not formed due to changing the position of easing arm.

Backrest roller bumping might well be enhanced by adjusting the position of the easing arm [15]. It results in greater jerking on the warp yarn. As a result, the short fibers of various yarns come into less touch with each other, and the inclination to create balls is lessened (Figure 12).

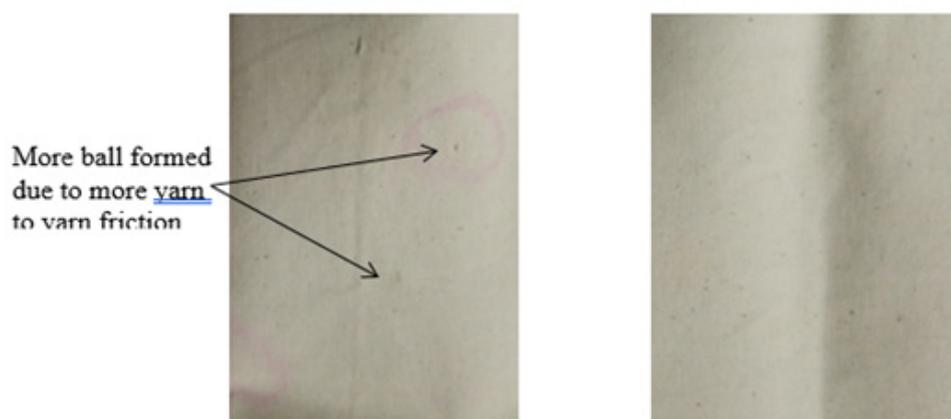
Figure 13: Less ball formed due to less yarn-to-yarn friction.

Backrest roller height and depth with drop wire height may be adjusted to obtain desired shed structure [8]. The shed angle may be controlled by altering the heald frame height. When the shed angle was raised to the optimal amount for the fabric structure and yarn count, warp yarn jamming was reduced. As a consequence, friction was minimized, and ball formation was also reduced (Figure 13).
